## **Grafton County Courthouse – Facility Concerns**

*(\*) Denotes 54-year-old original equipment dating back to 1971 when the building was initially opened*

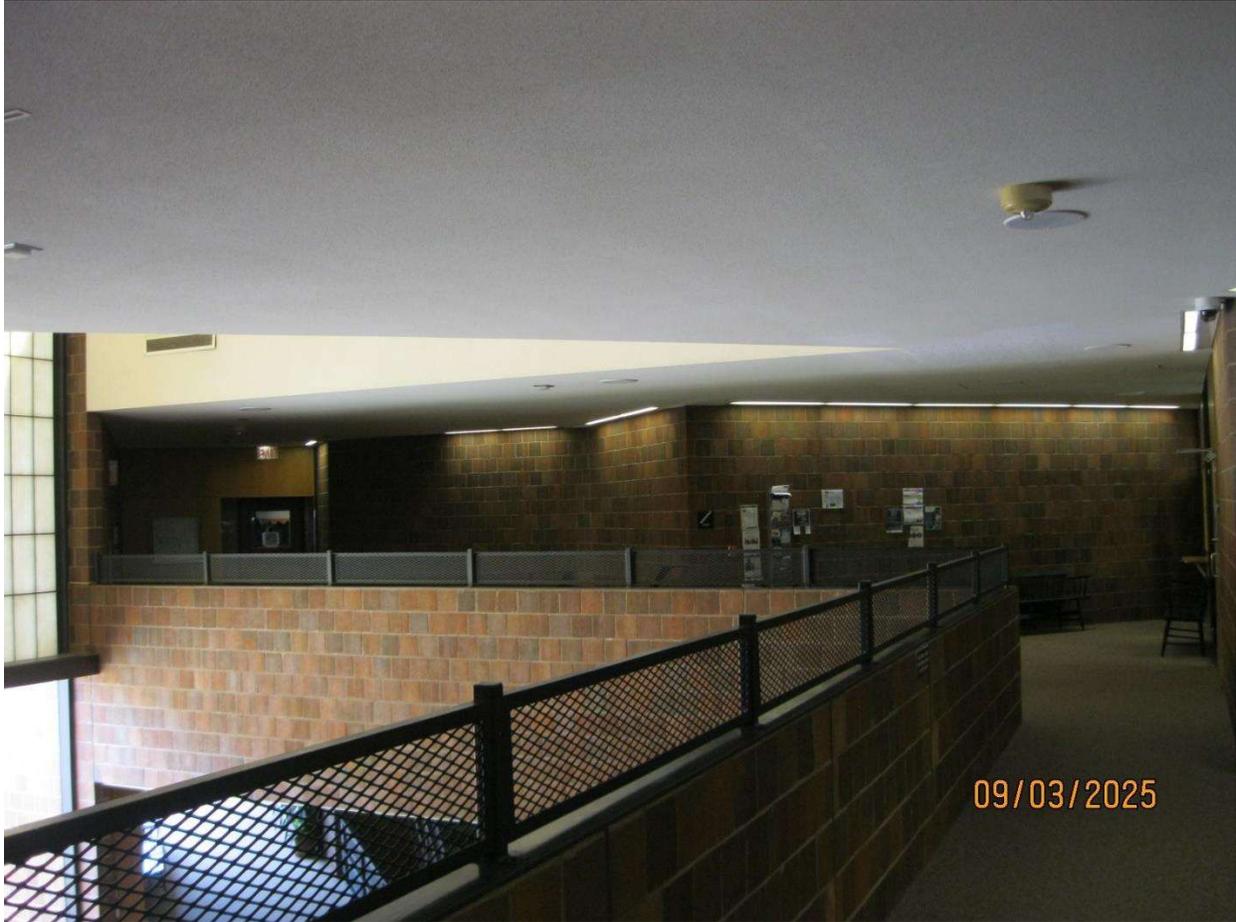
Sprinkler System: \* The building does not have a sprinkler system as attested in the picture below. 1970 building code did not require it at the time of construction, but today's code does require it based on occupancy levels.

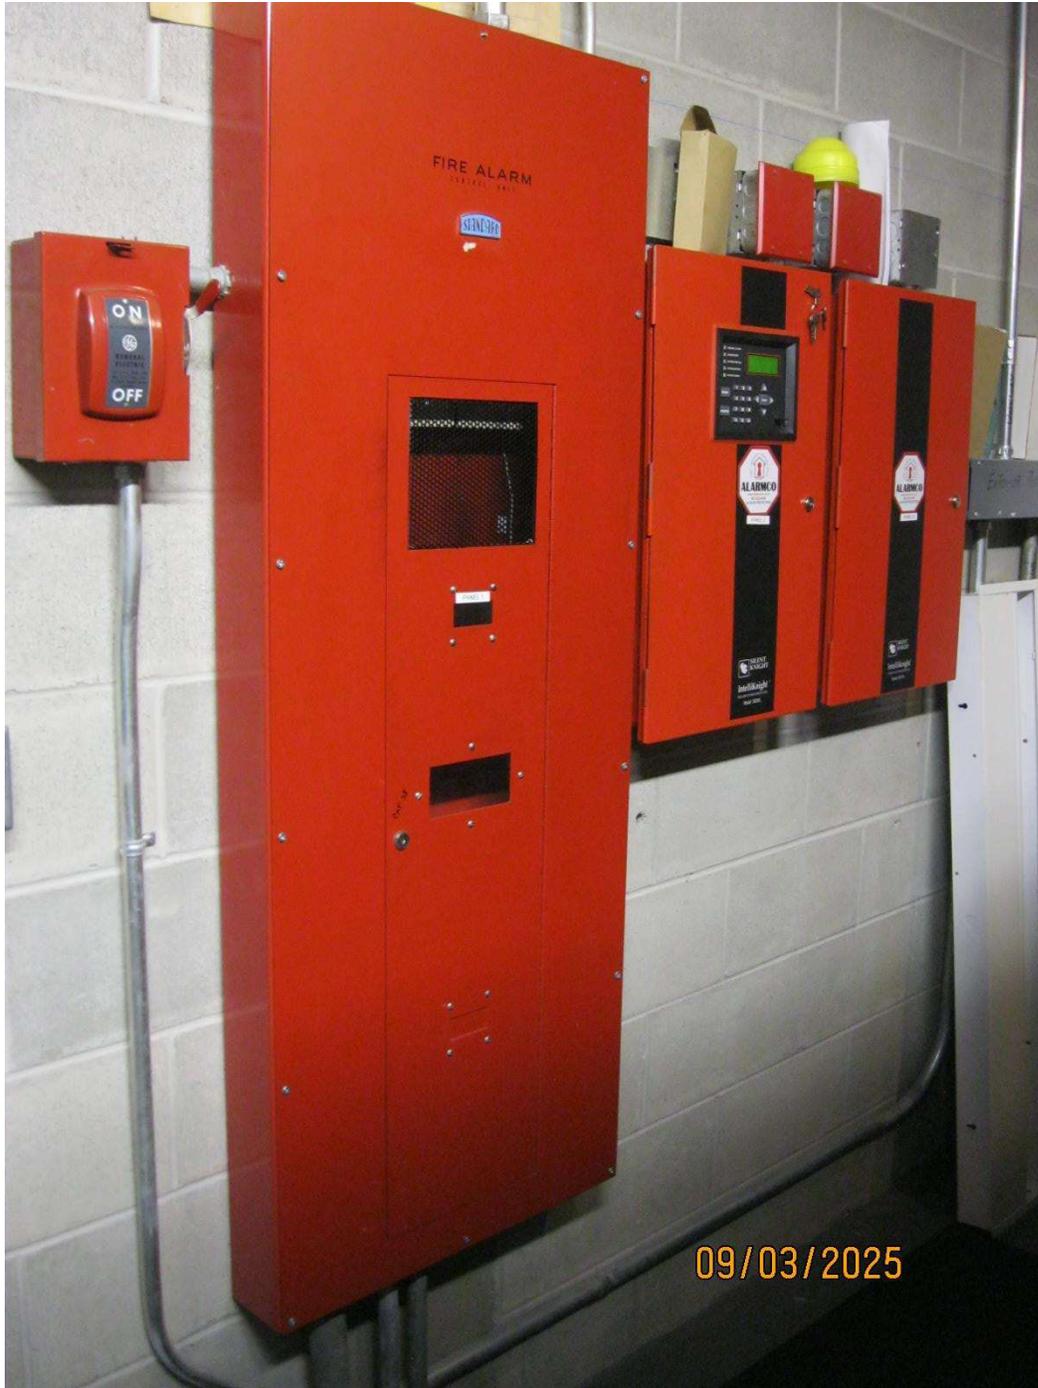
Fire alarm system: The original system was a bare-bones zoned system that gave general coverage but lacked specificity as to a fire's exact location. Although we upgraded the system to address this issue, the improved system is marginal when compared to a new building's fire alarm coverage and abilities

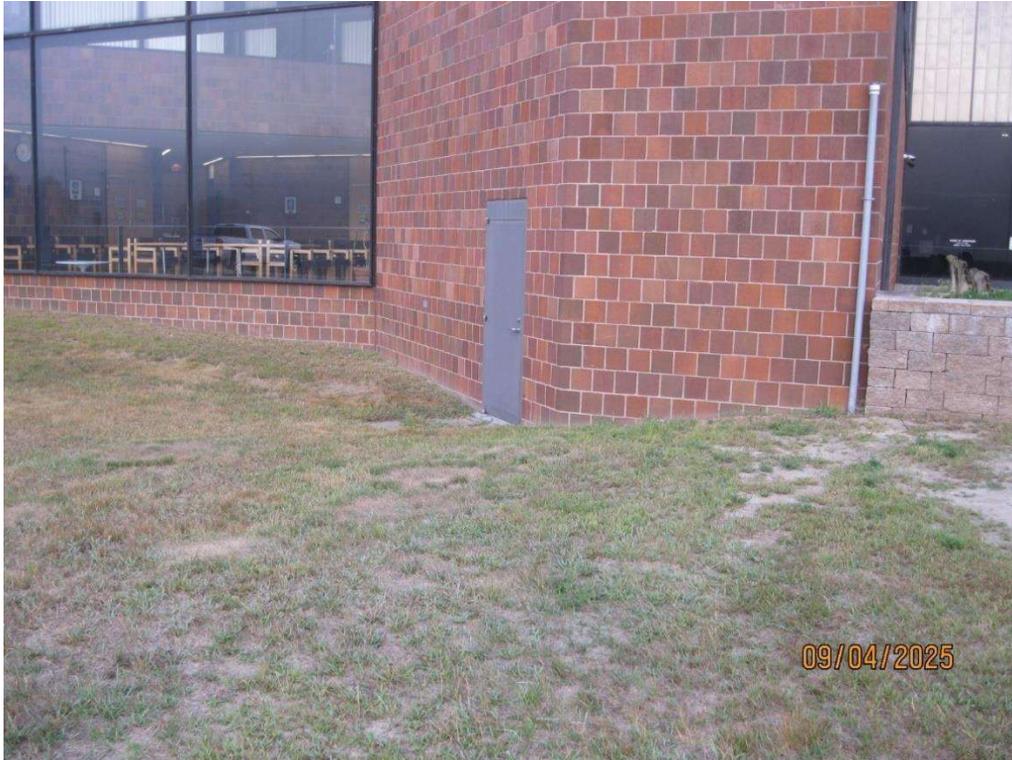
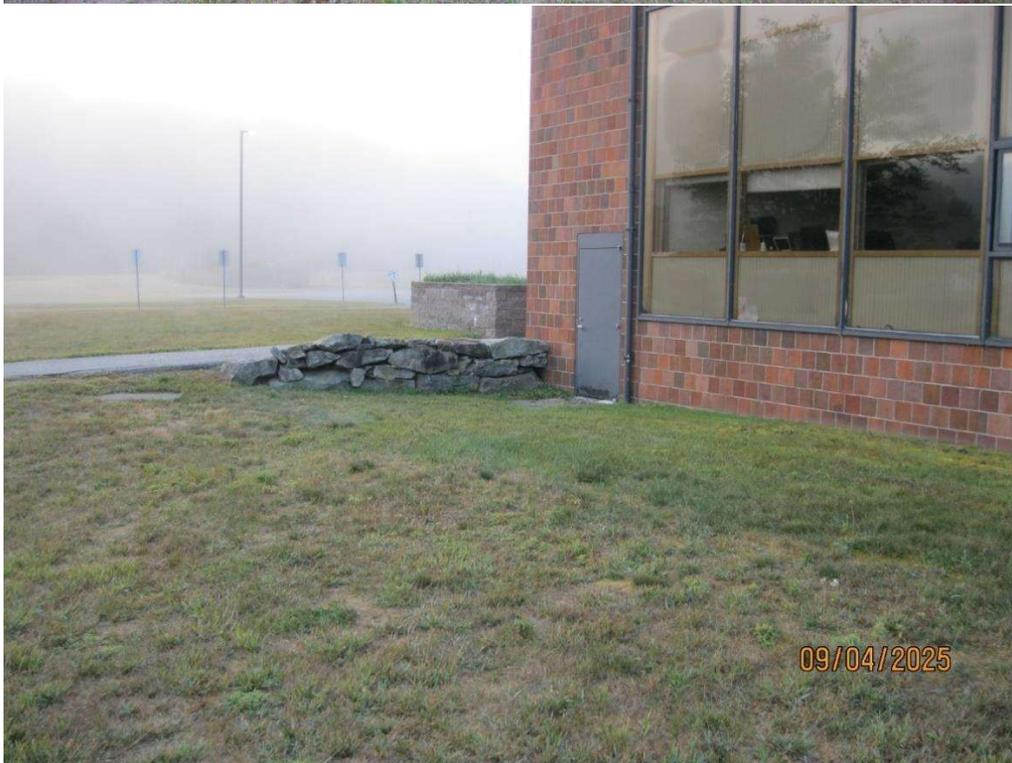
Egress Routes: \* Due to poor engineering, the two main emergency exit areas are below grade and interior stairwells are prone to flooding in the springtime, hindering egress from the building. In early spring one year the North exit door froze in place and was unusable. To free the door up we had to remove the threshold.

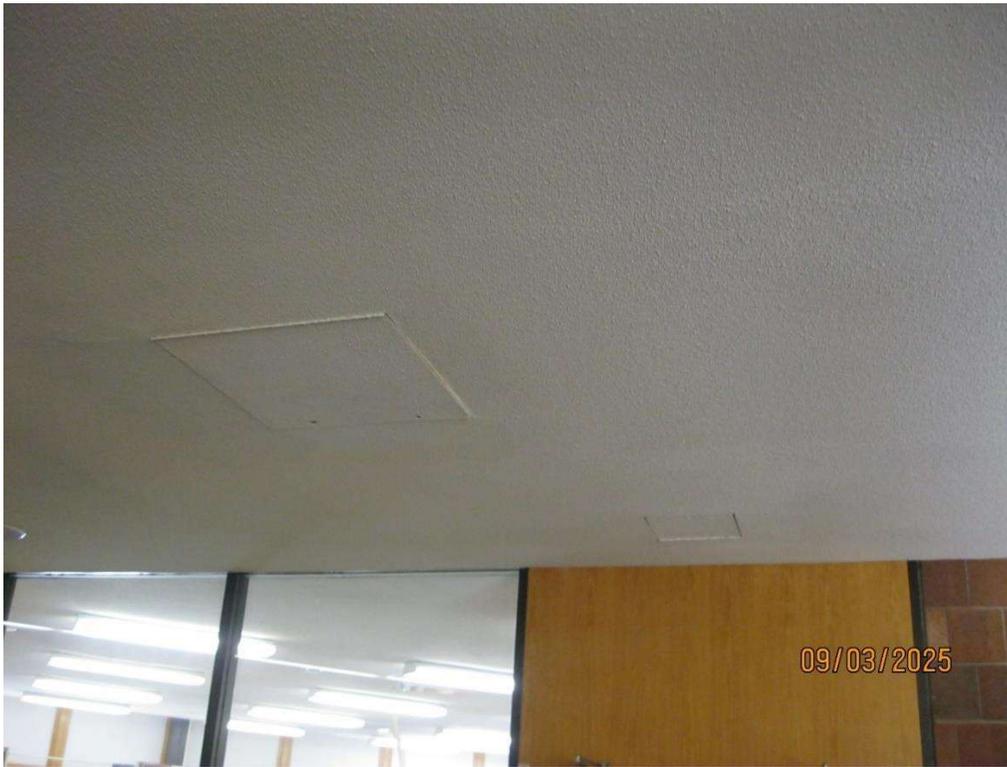
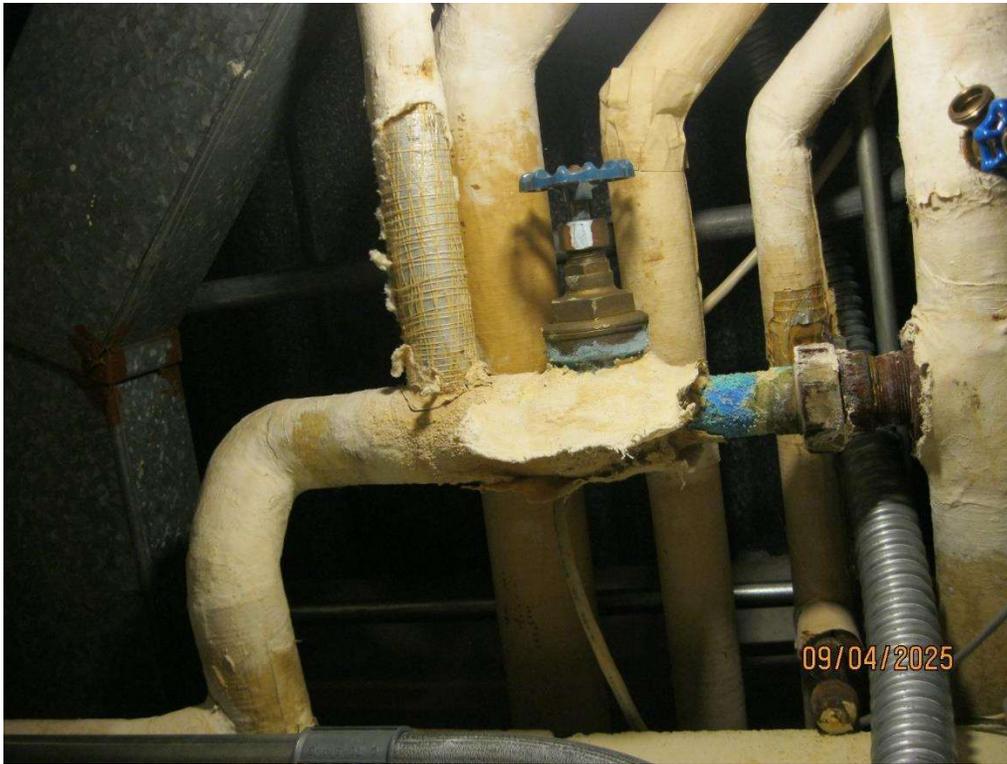
**Asbestos:** \* Most of the ceilings in the building are coated with an asbestos material and virtually all pipe fittings are wrapped in asbestos as well.

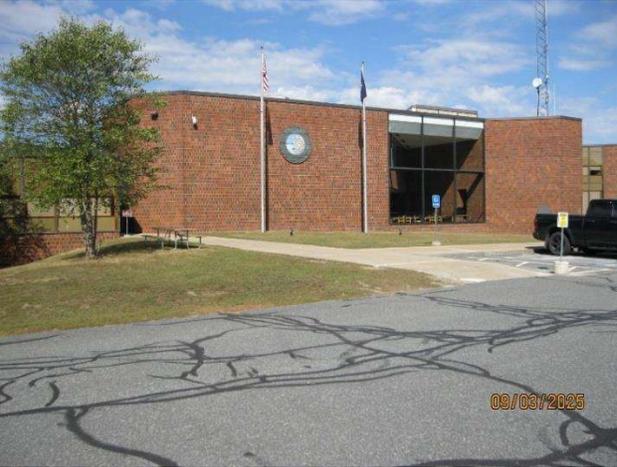
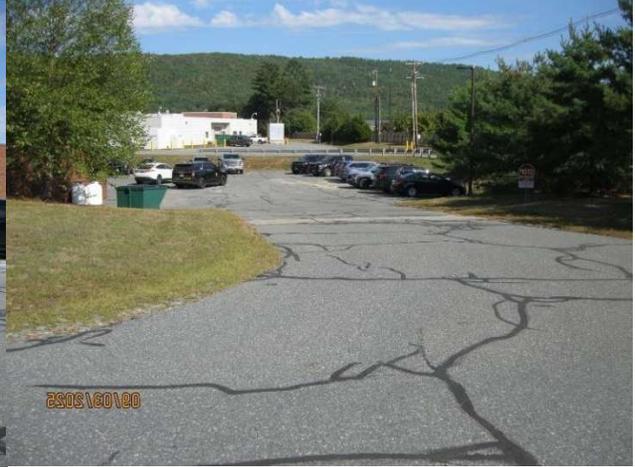
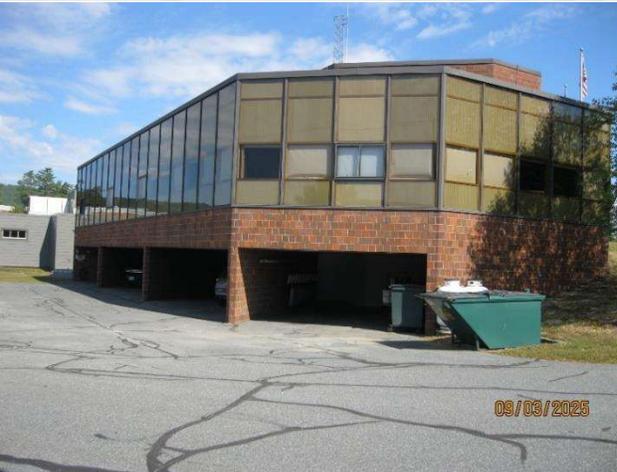
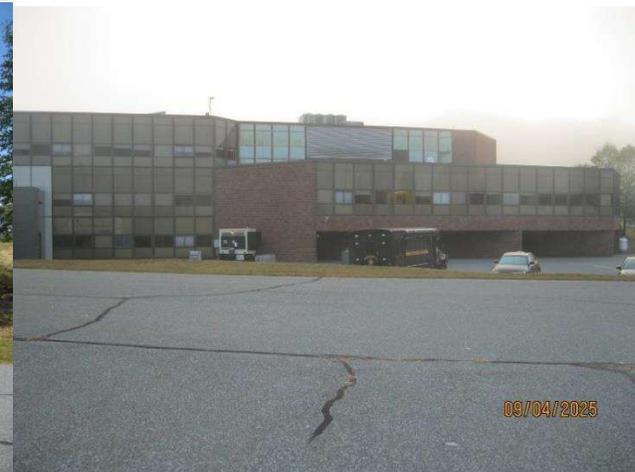
Exterior Barriers: \* The facility lacks exterior barriers in key locations (lobby, jury panel room, parking below judicial chambers, generator, etc.) to prevent vehicles from impacting the building.

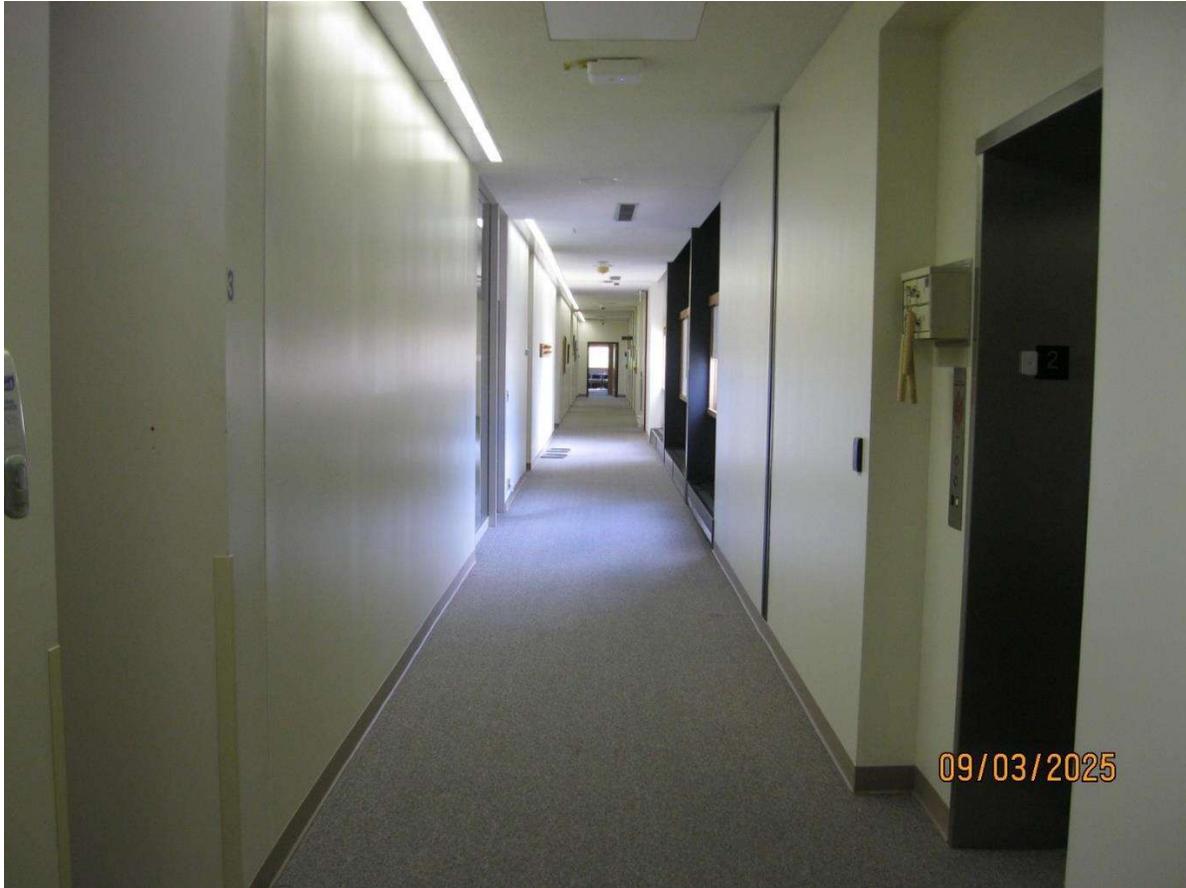
Segregation of Inmates & staff: \* The building lacks segregation of inmates and staff. Inmates must be escorted from the DOC and through judicial staff areas for court appearing's because there is no other route to avoid crossing paths.

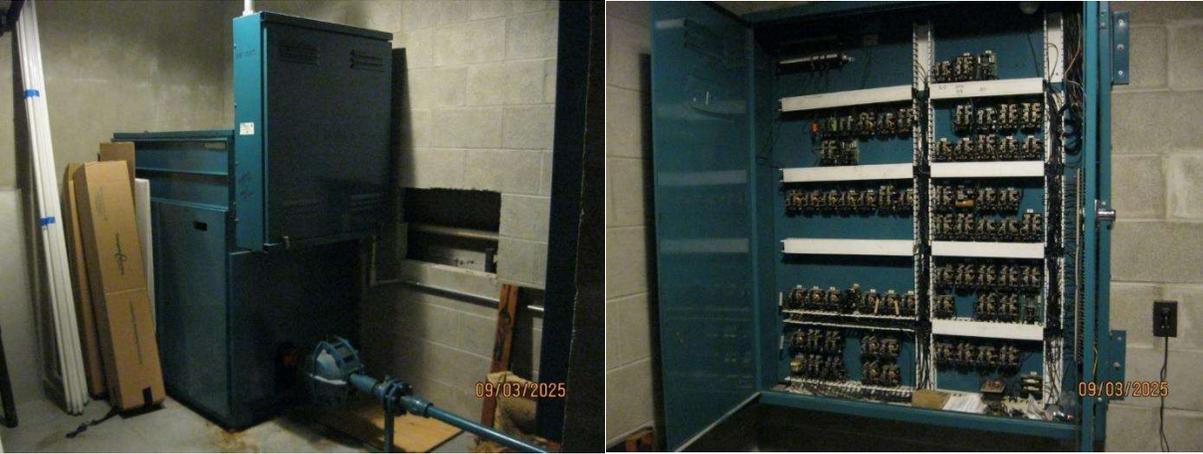
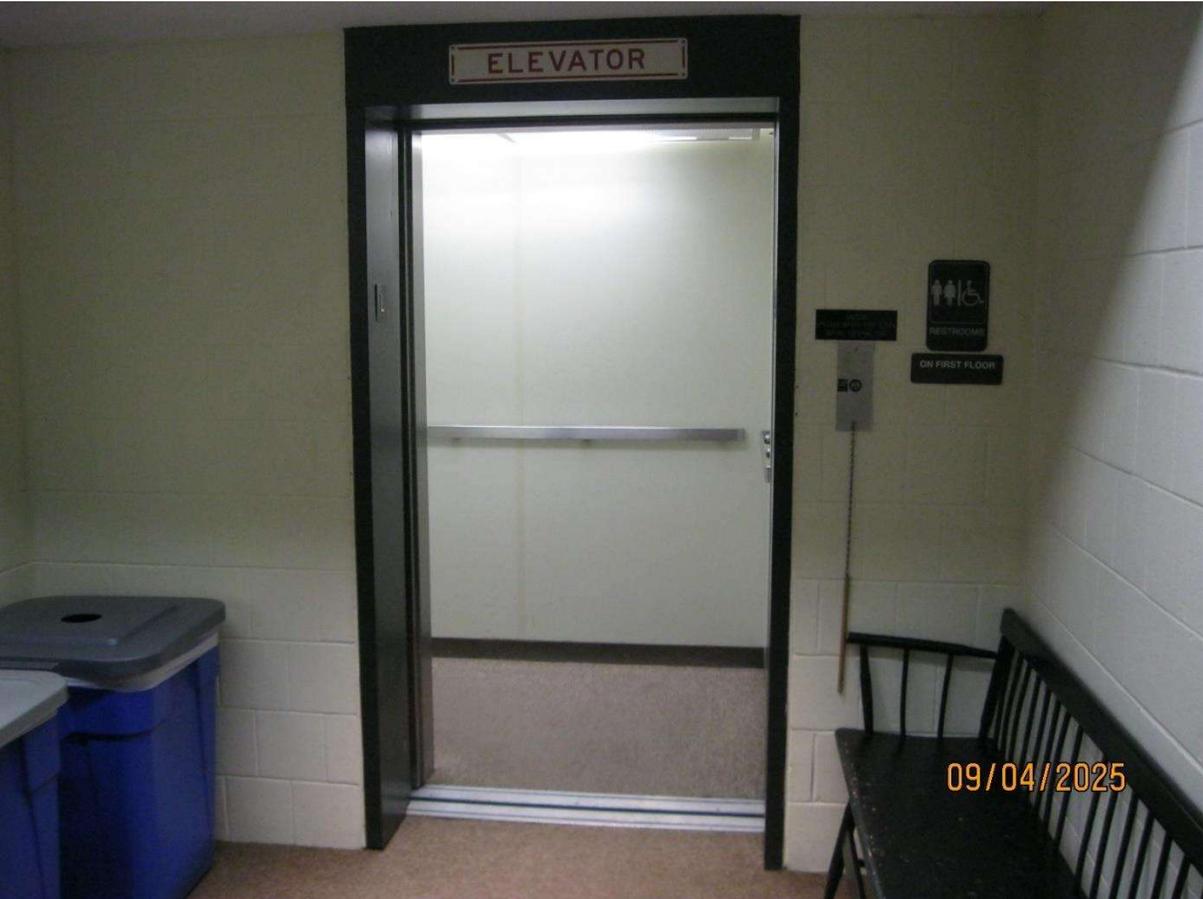
\* Elevator: Certain parts are no longer available (i.e. leveling valve, relays, etc.)

- Lacks modern-day fire safety features (grandfathered by State of NH)
- Lacks true ADA compliance (buttons are too high...must use hanging wand to tap buttons)
- Electrical load exceeds generator's capacity so it is not connected

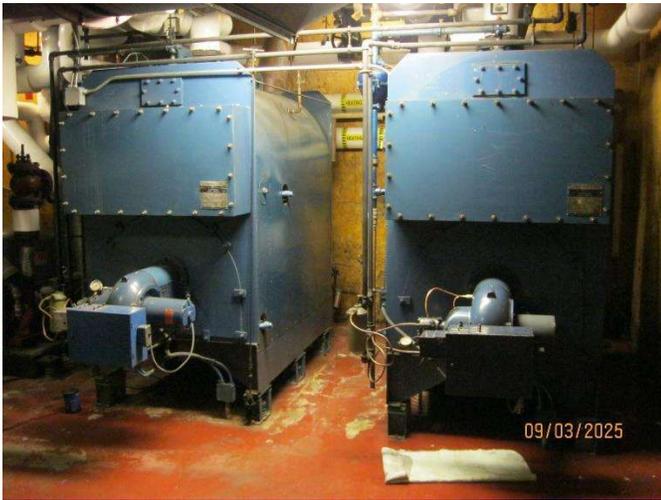
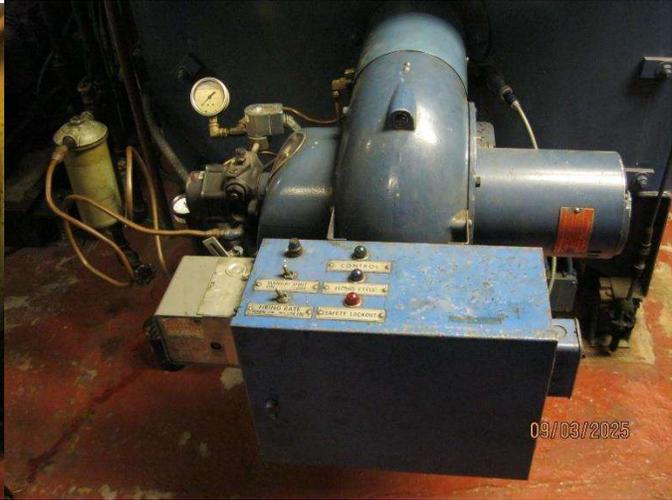
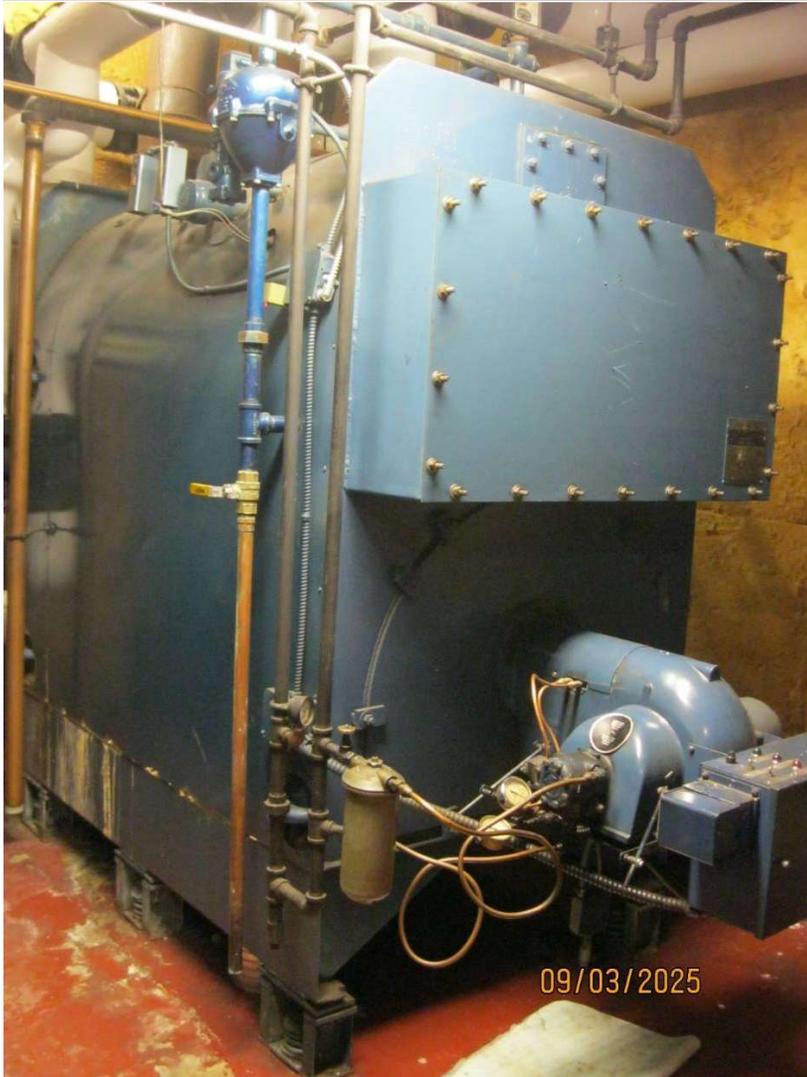
\* Boilers: It is difficult to find replacement parts (i.e. low water cut outs and fuel nozzles are a few examples)

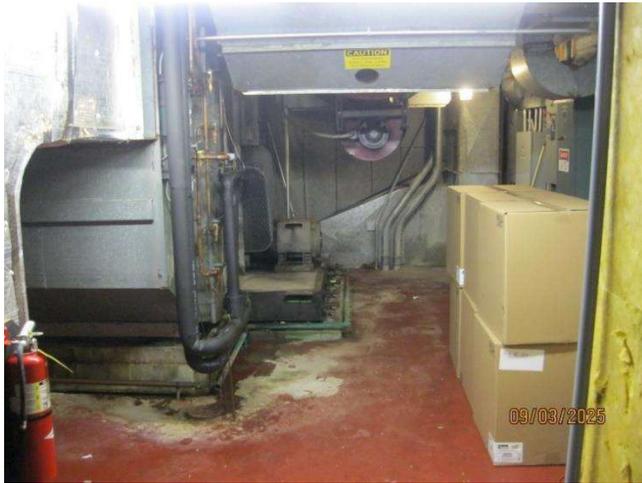
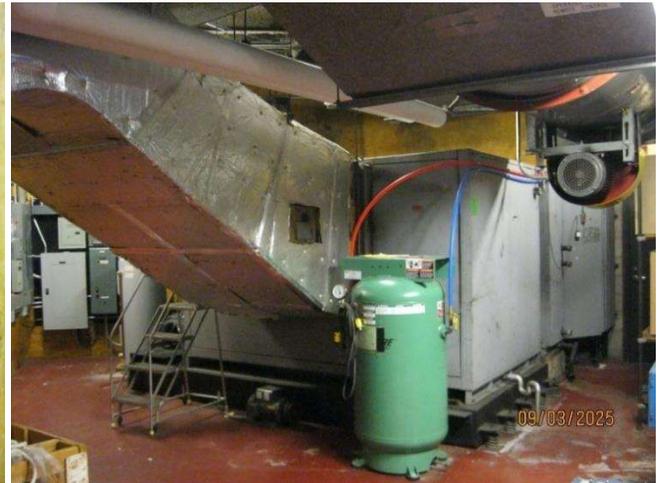
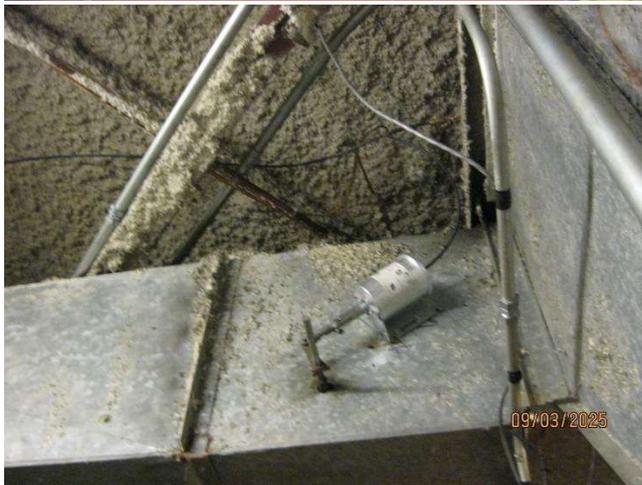
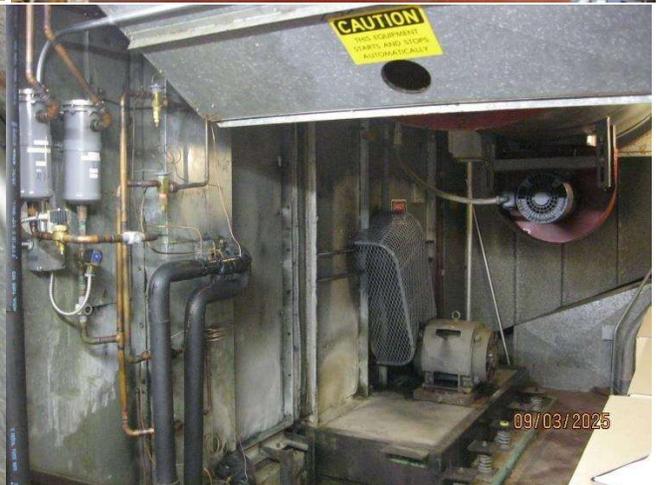
\*Air handlers AC1 and AC2: Several studies show these units have had air balancing and control issues since installation, thus are extremely difficult to regulate the zoned areas they serve and keep everyone happy.

- Pneumatic controls (original) - obsolete parts and rubber parts degradation
- Ductwork insulation on interior (Concerns about doing duct cleanings and disintegration of insulating materials due to age)
- Numerous variable air volume heat boxes throughout. Many of the gate valve isolation valves for these units are seized open due to mineral deposits. Attempts to isolate them in the past has resulted in broken handles. Any further attempt to operate them now will likely result in disastrous results due to lack of larger loop isolation valves and restricted access due to a scarcity of adequately sized access doors in the asbestos ceilings.

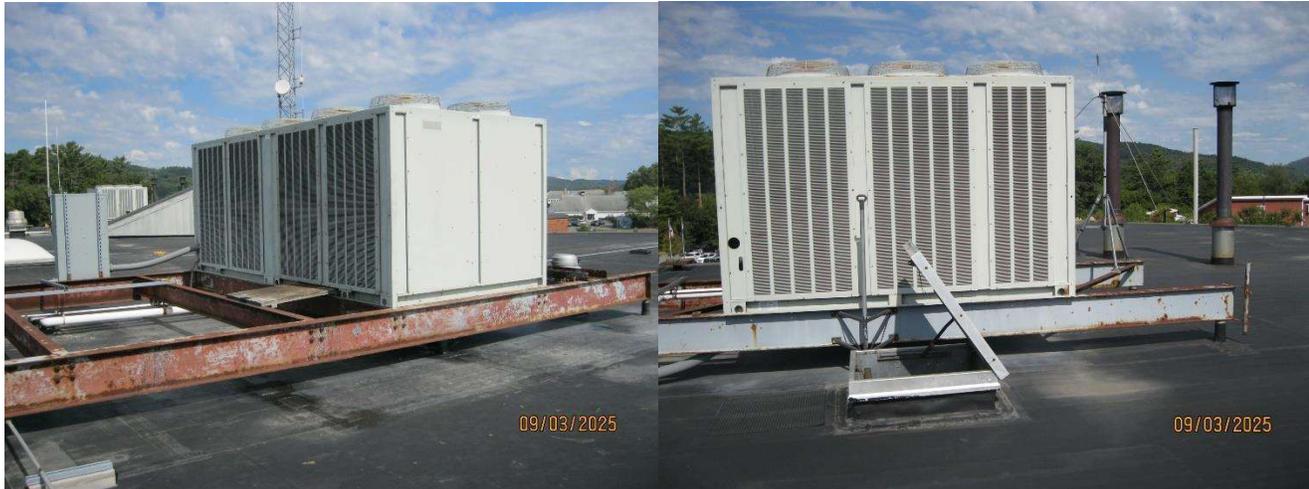
Air condition condensing units are 23-years old and at the end of their life expectancy. The R22 refrigerant they use is hard to get and extremely expensive. In the past few years a proliferation of repairs has cost the county a lot of money to keep them going.

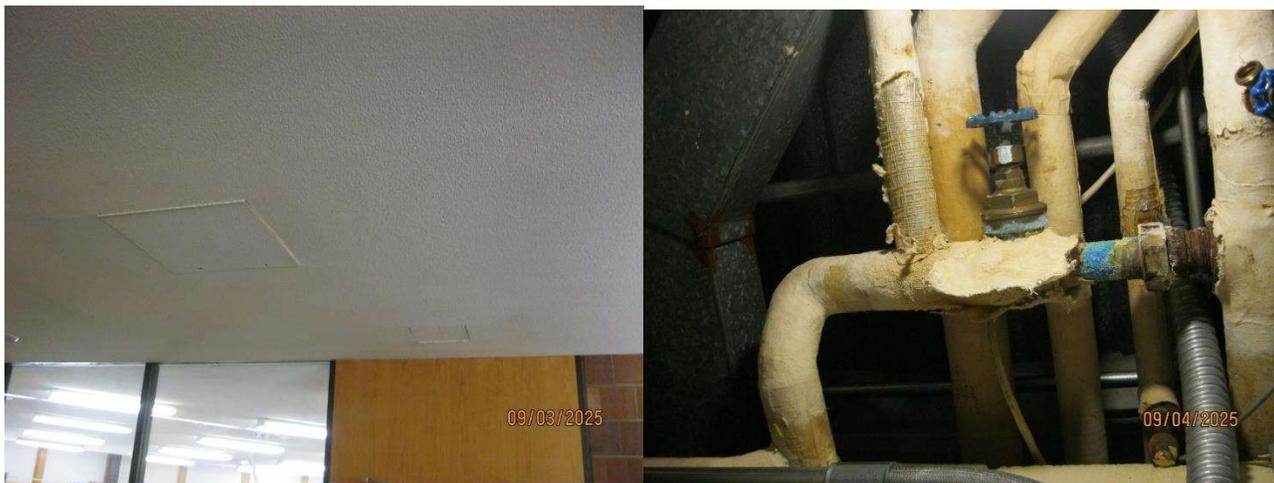
\*Plumbing Much of the plumbing is encased in inaccessible concrete chases or above asbestos ceiling with little to no access. As leaks occur we have to cut access holes into the chases or completely abate asbestos ceilings to access and fix leaks. Ceiling access points are mostly small and limited, which inhibits reasonable access to much of the mechanicals, electrical and plumbing.

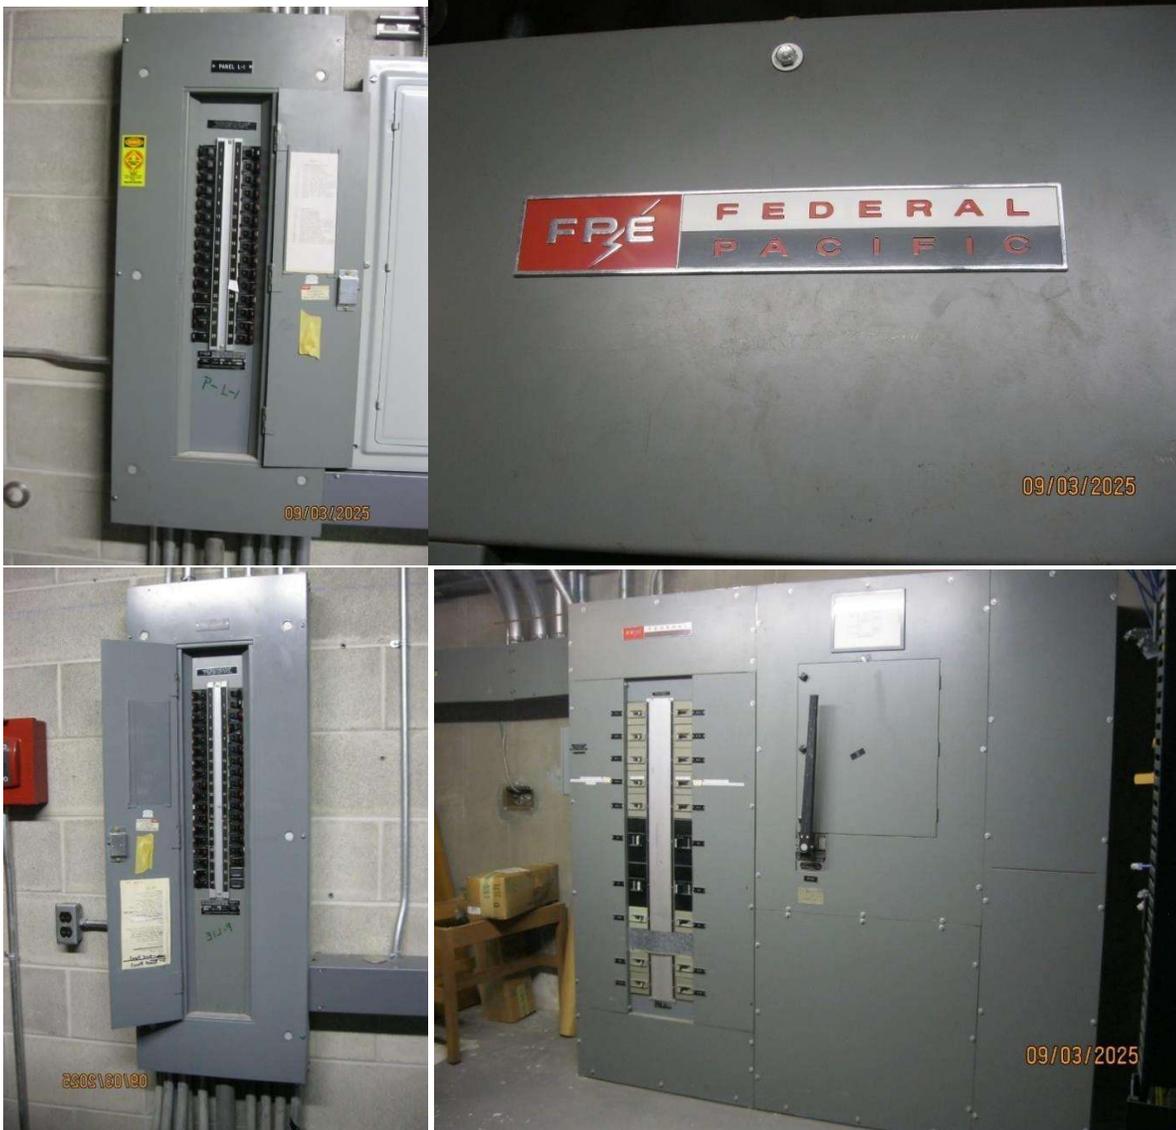
Electrical \* The buildings electrical system is a Federal Pacific system. Federal Pacific was caught falsifying its UL records and subsequently went bankrupt due to a class-action lawsuit. The issue was, their circuit breakers often didn't trip when loads exceeded ratings and was cause for fires. See attached weblinks for details.

- \* Mixing of 110v and 220v combination outlets (no longer meets code)
- \* Using conduit as means of ground (no longer meets code)
- \* Shared common neutrals (no longer meets code)
- Generator covers absolute basics (Dispatch, egress lighting, fire panel, boilers and hydronic pumps). All other occupants can't work in the building during an extended outage.
- Utility and generator circuits run in some shared raceways and shared rooms in various locations

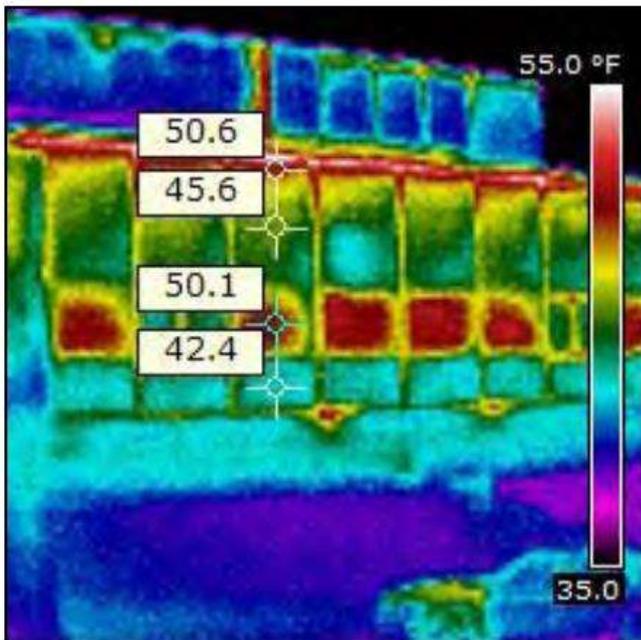
South façade of Courthouse

Insulation \* - Other than the roof, which has 4-inches of foam insulation panels, the rest of the building's foundation, exterior brick walls, Kalwall translucent panels (fiberglass panels) and single-pane glass curtain walls are essentially uninsulated. Thermal gain in the summer is intensive.

Using an infrared camera on a 30° Fahrenheit day, thermal scans from a 2009 energy audit revealed massive heat losses and assumes the same for cooling losses in the summertime. Below are a few images

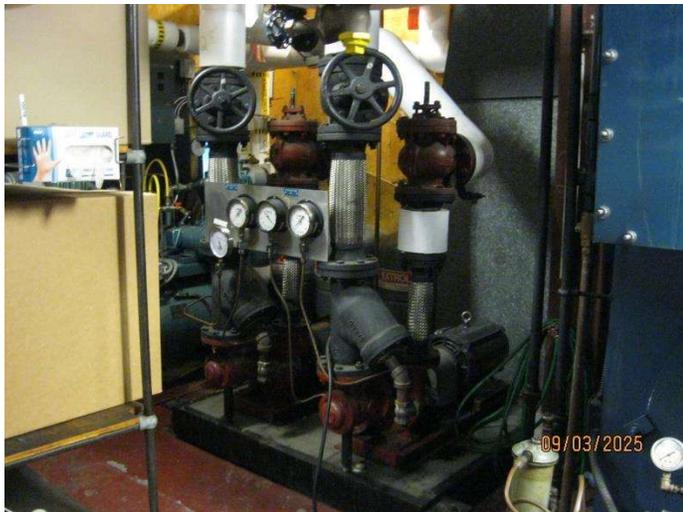
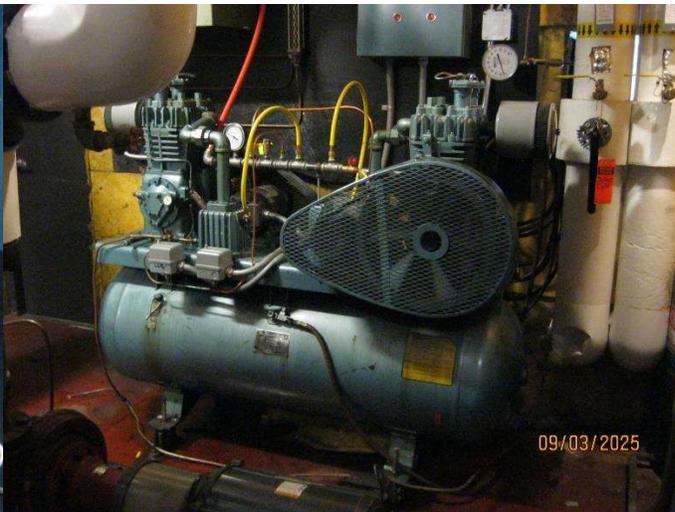
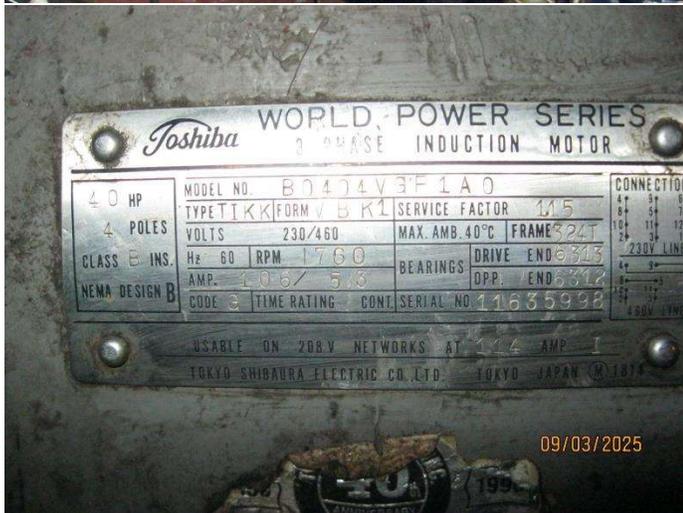
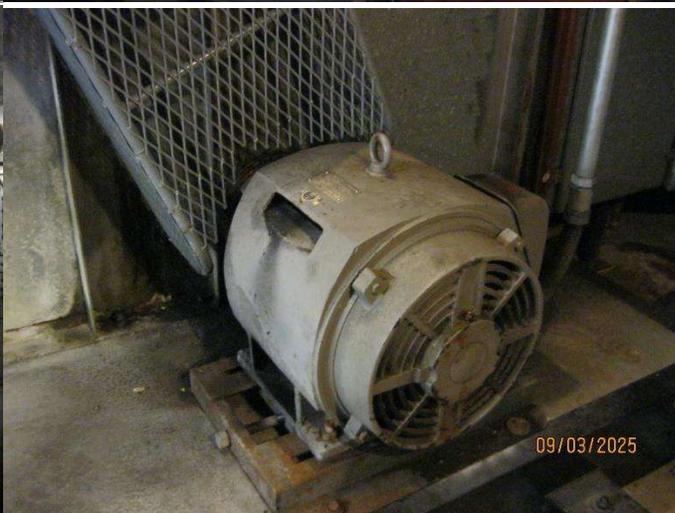
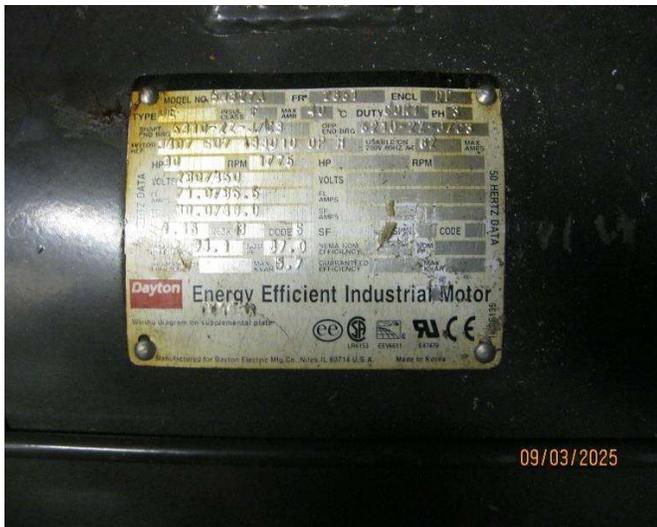
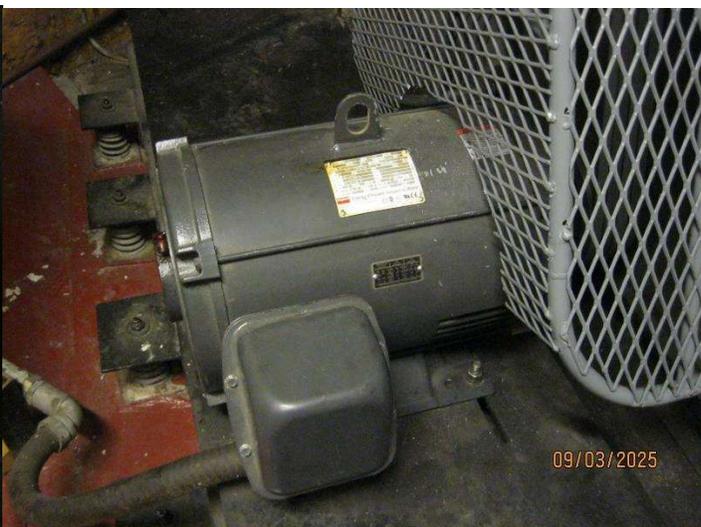
Mechanicals - Virtually all of the mechanical equipment (boilers, pumps, air handlers, etc.) are 55-year old equipment and well beyond their life expectancy. Although still operational, they are hugely in efficient when compared to modern day replacements.

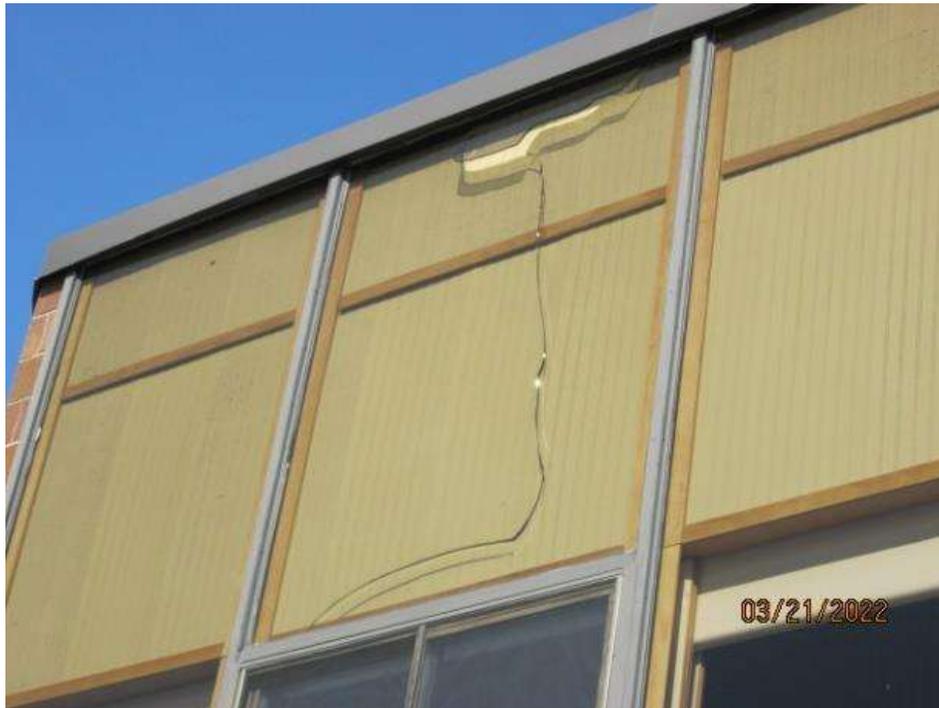
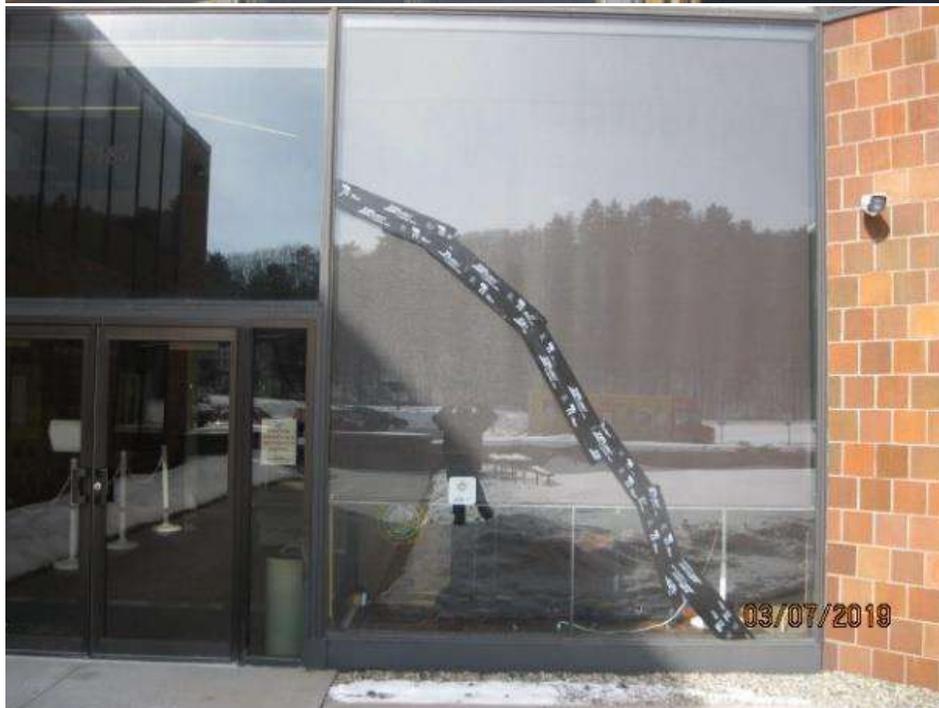
Glass curtain walls – The steel frame interiors are rusting and the pressure from the expanding rust leads to cracking of these massive windows. The windows then break into large jagged shards, unlike today’s safety glass designed to break into small pieces to mitigate injury. Replacement glass must be safety glass and thus it can be problematic procuring the large sizes we need due to tempering oven size limitations. Lastly, replacement glass is quite expensive. For example, in April 2019 it cost \$11,510 to replace one pane of glass at the main entrance.

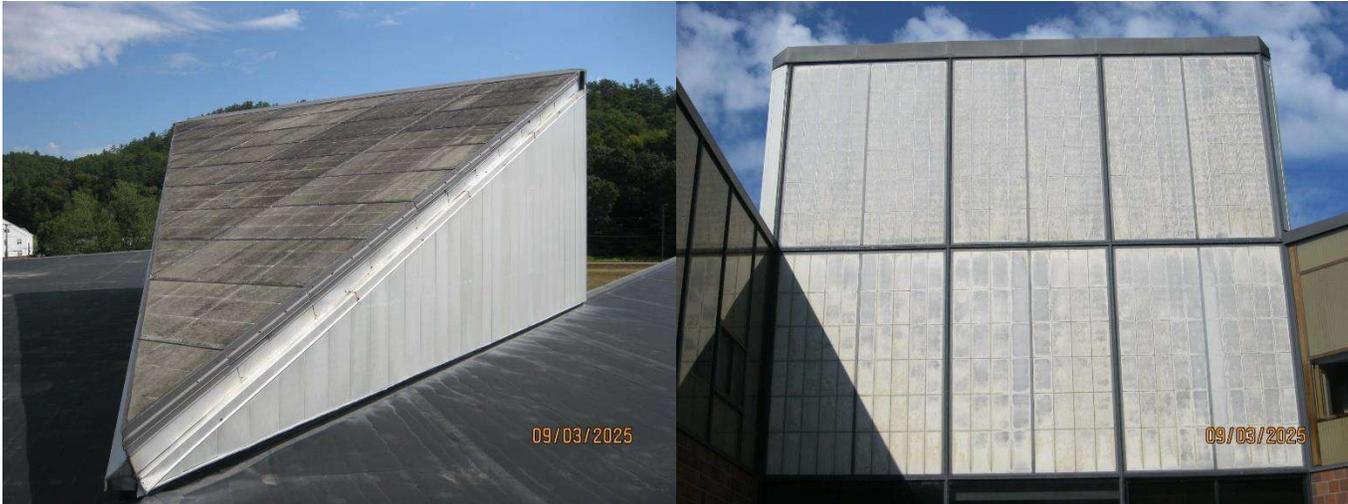
Kalwall Translucent panels (fiberglass) – The front entrance curtain wall and atrium roofing over the lobby are made up of Kalwall translucent panels. UV rays have degraded the panels to where they are thin and brittle. They are well beyond their life expectancy and sometimes leak during a driving rain.

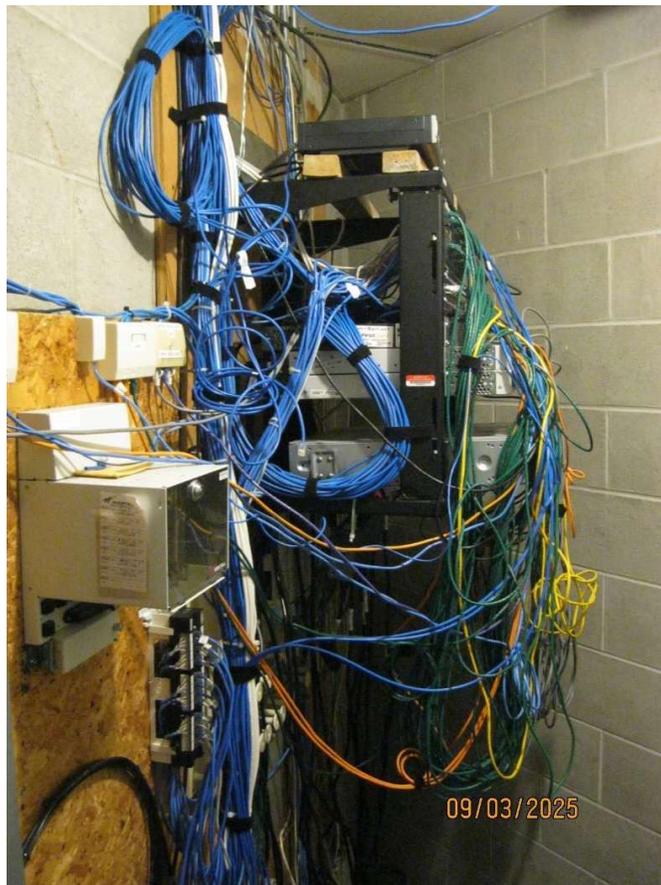
**IT closets** – The building was never constructed to support IT equipment. Over the years the county and state IT departments set up their equipment wherever they could. Most are jammed into cramped electrical rooms that are not air conditioned.
