## **Grafton County Courthouse – Facility Concerns**

*(\*) Denotes 54-year-old original equipment dating back to 1971 when the building was initially opened*

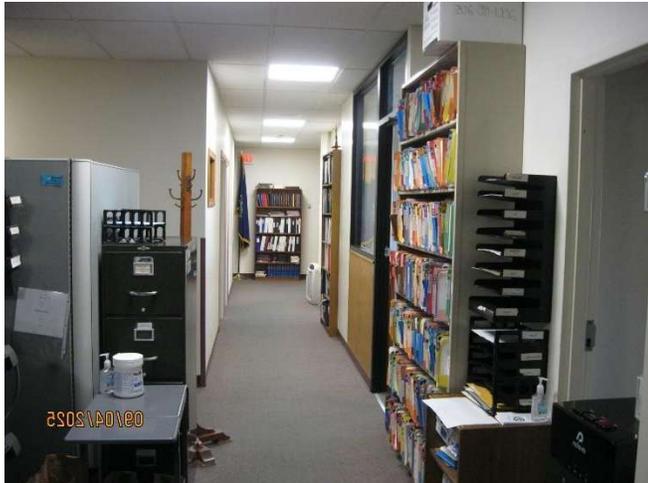
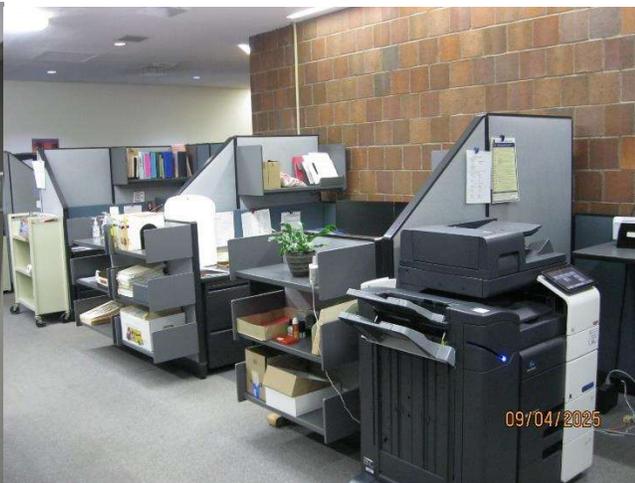
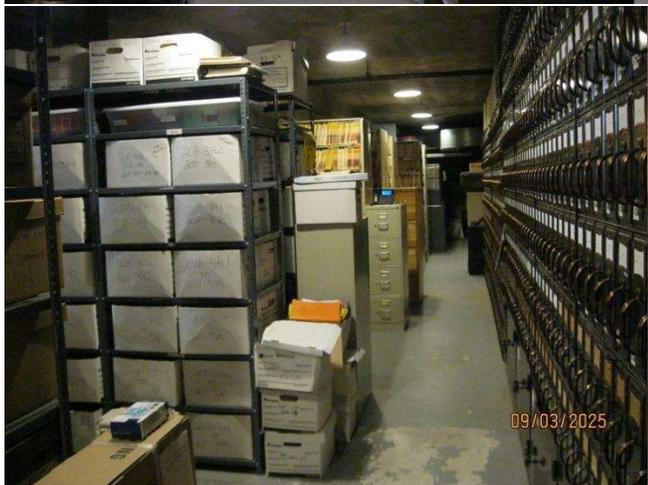
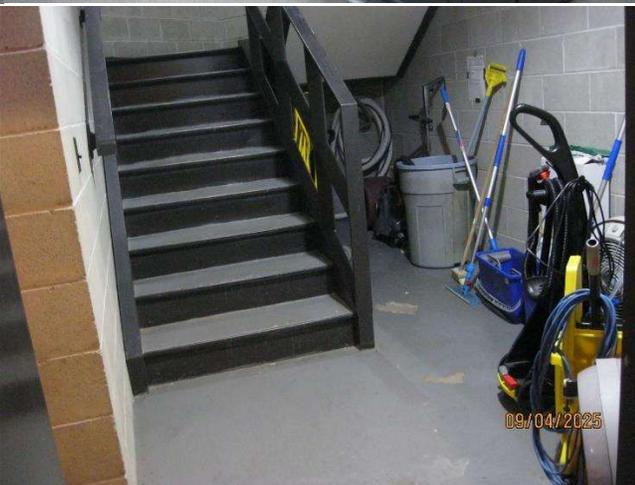
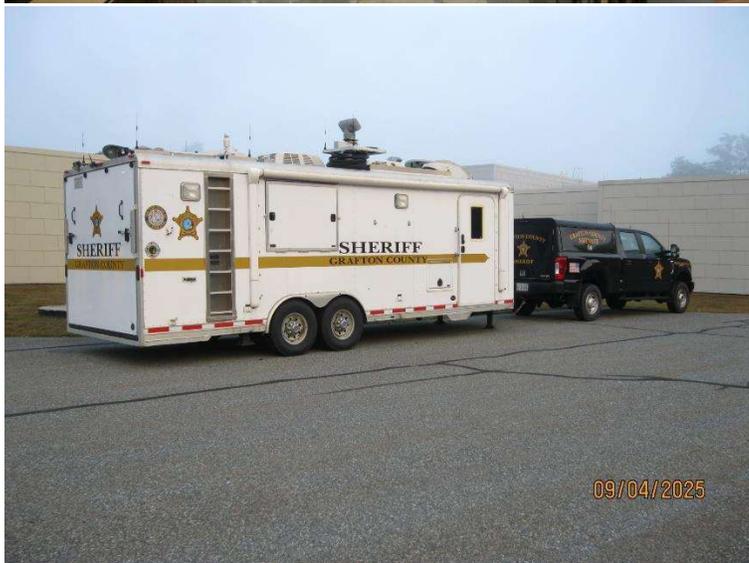
**Office Space & Storage** – Virtually all departments and agencies have grown exponentially since the building opened in 1970. Today, many staff areas are cramped and lack of adequate storage space has caused storage to encroach into staff areas and stairwells. Shared storage is jam-packed and overflow often jams office space. Dispatch’s Mobile Command Center trailer and tow vehicle sit out in the weather and should be garage to promote longevity.

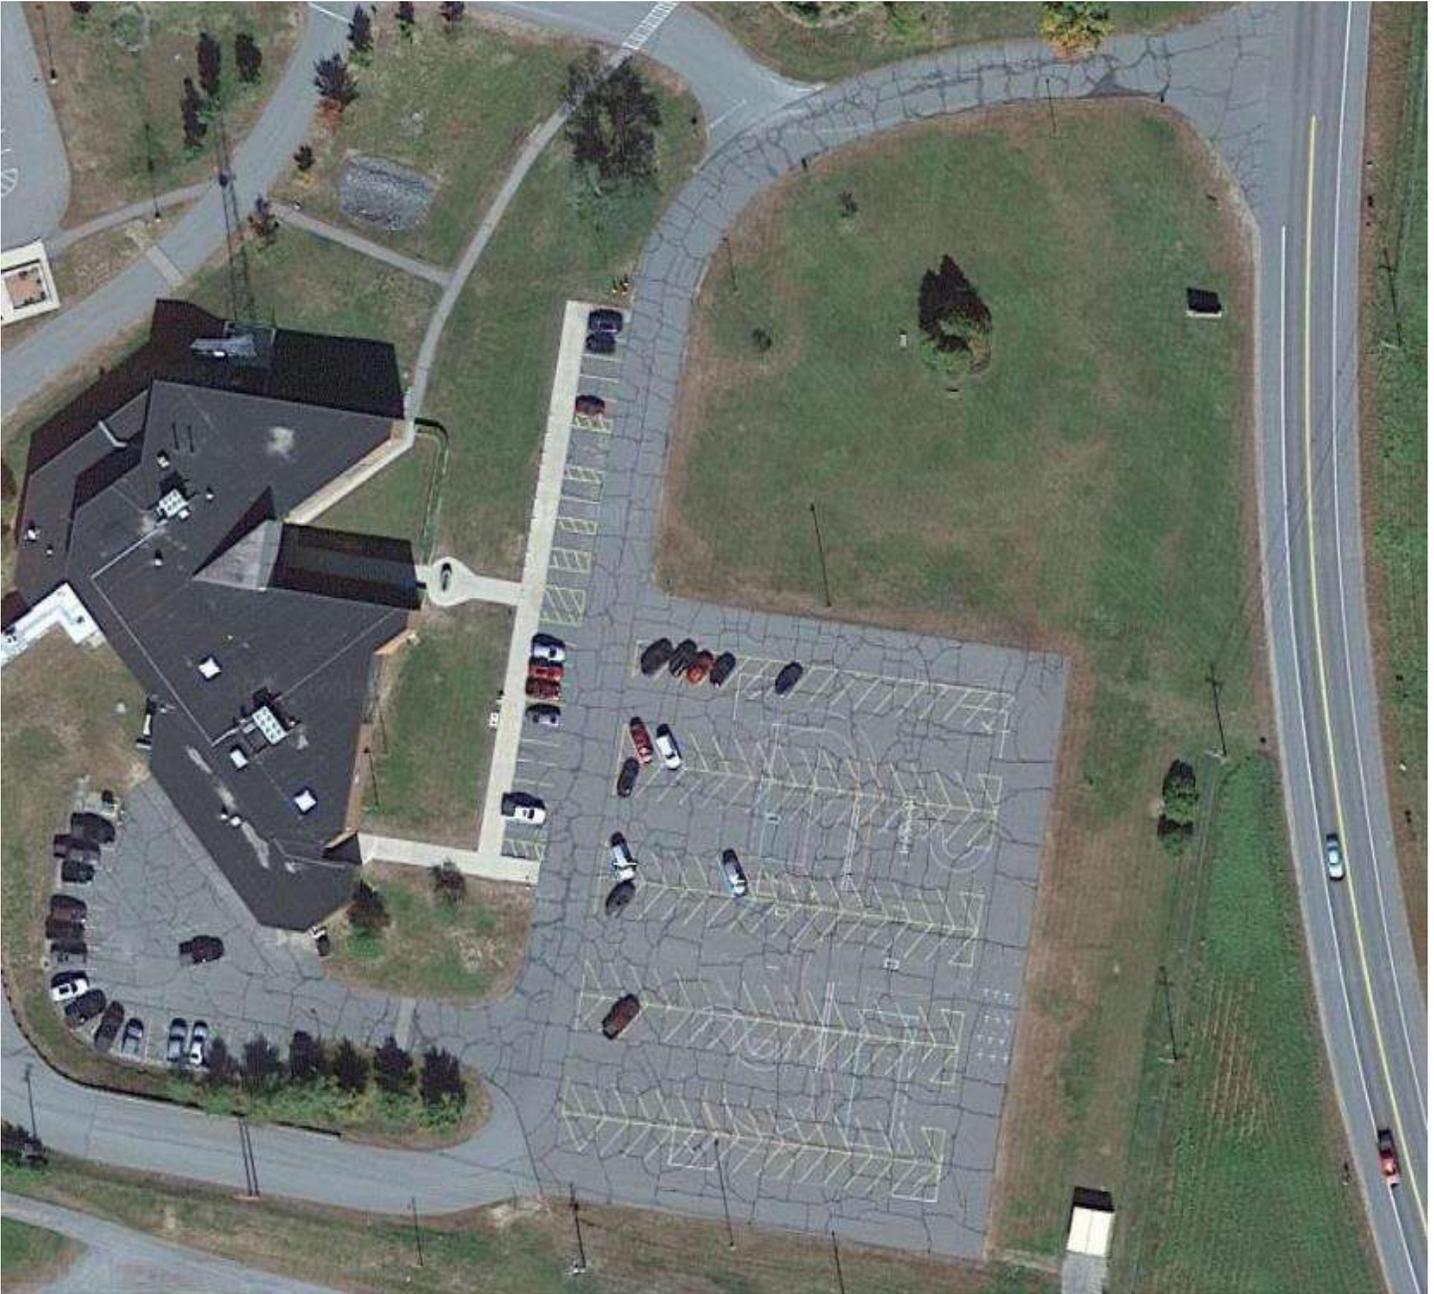
**Parking Lot** – The pavement is degraded to the point where the base material has failed, which requires complete removal and replacement.
