Grafton County Courthouse – Facility Concerns

(* Denotes 54-year-old original equipment dating back to 1971 when the building was initially opened

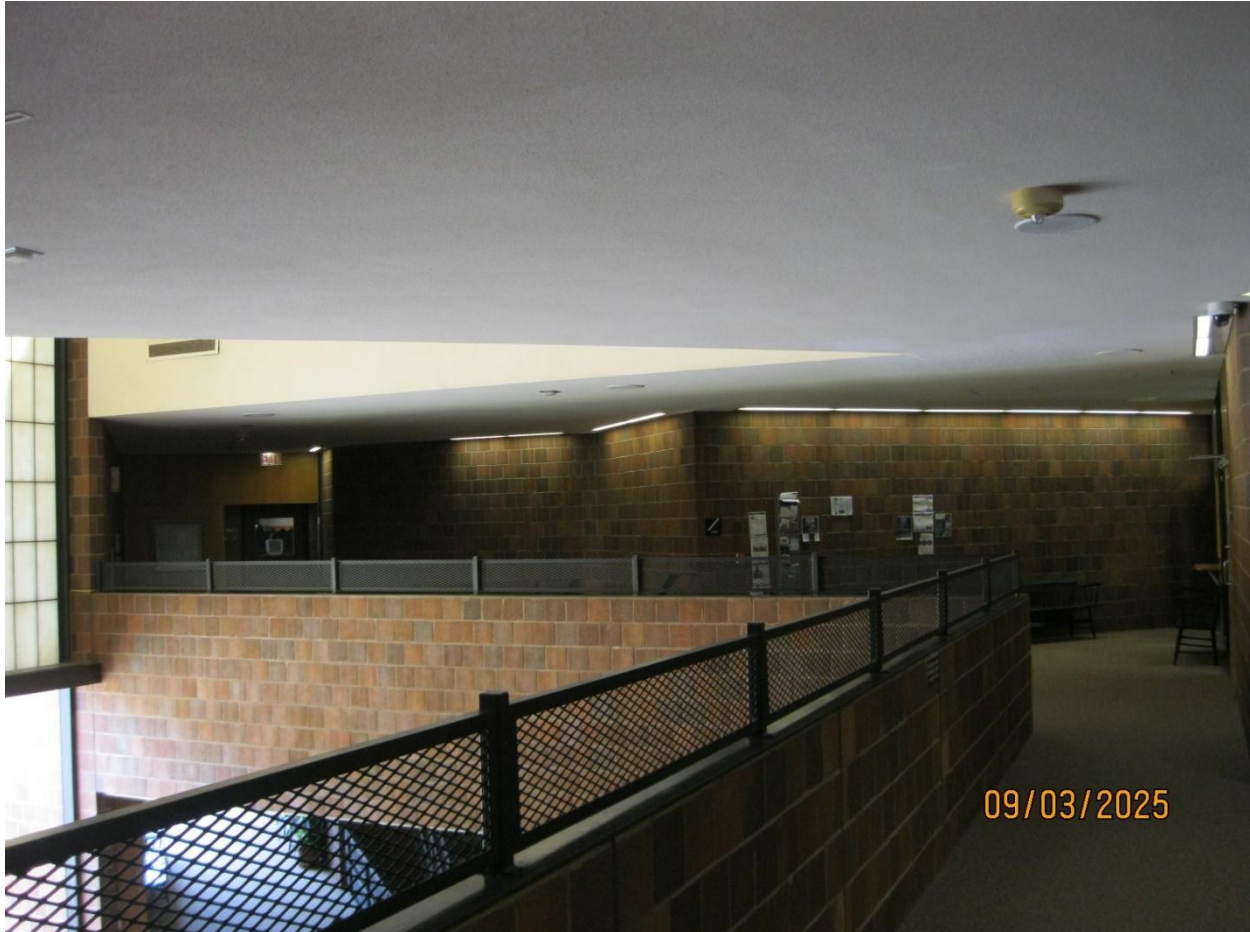
Sprinkler System: * The building does not have a sprinkler system as attested in the picture below. 1970 building code did not require it at the time of construction, but today's code does require it based on occupancy levels.

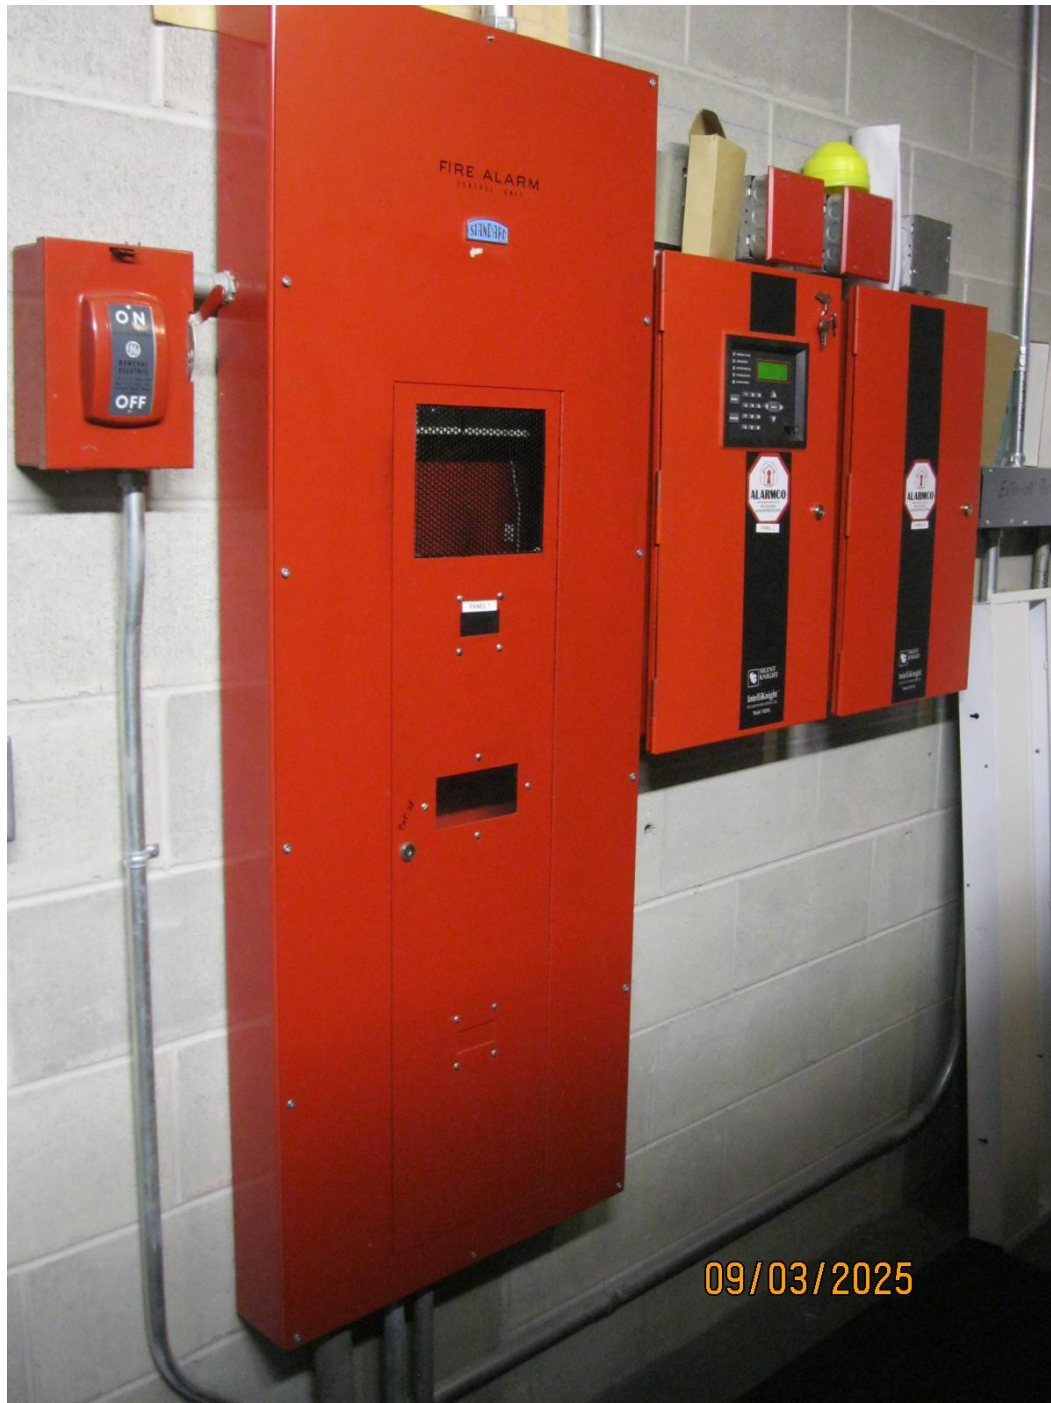
Fire alarm system: The original system was a bare-bones zoned system that gave general coverage but lacked specificity as to a fire's exact location. Although we upgraded the system to address this issue, the improved system is marginal when compared to a new building's fire alarm coverage and abilities

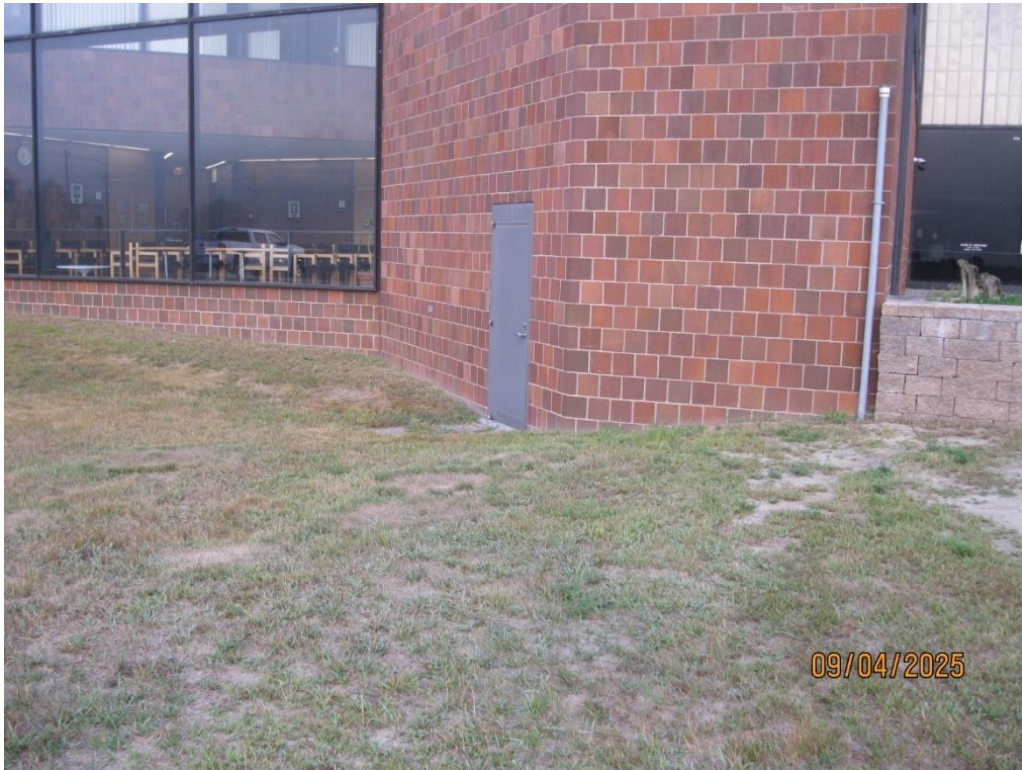
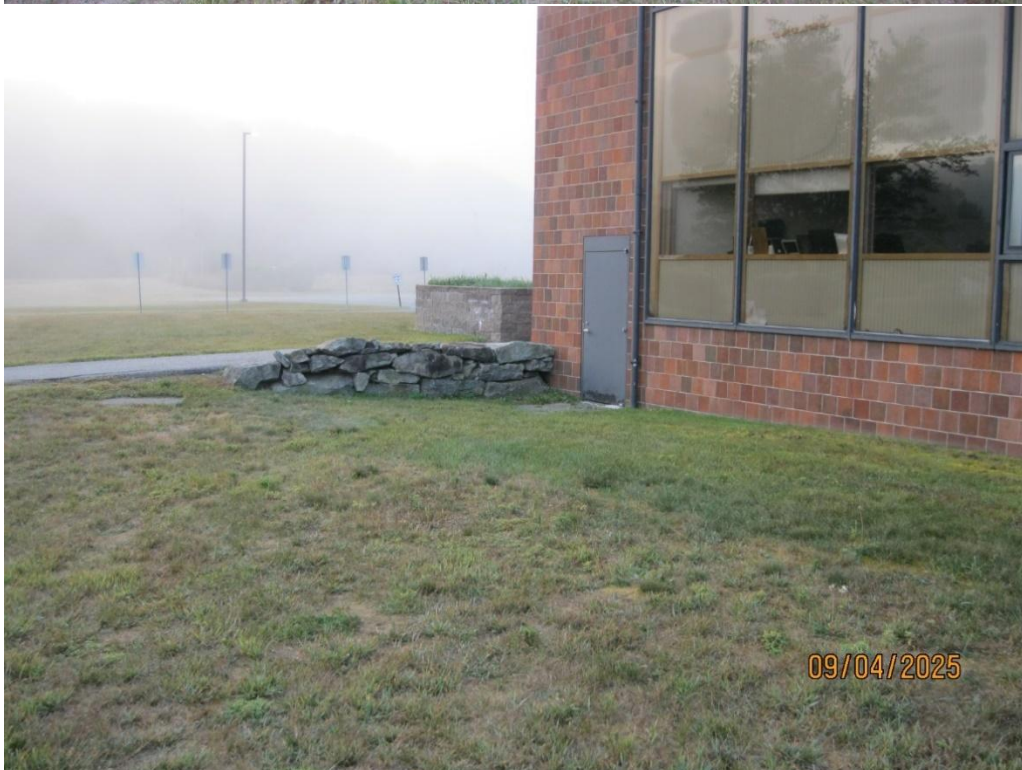
Egress Routes: * Due to poor engineering, the two main emergency exit areas are below grade and interior stairwells are prone to flooding in the springtime, hindering egress from the building. In early spring one year the North exit door froze in place and was unusable. To free the door up we had to remove the threshold.

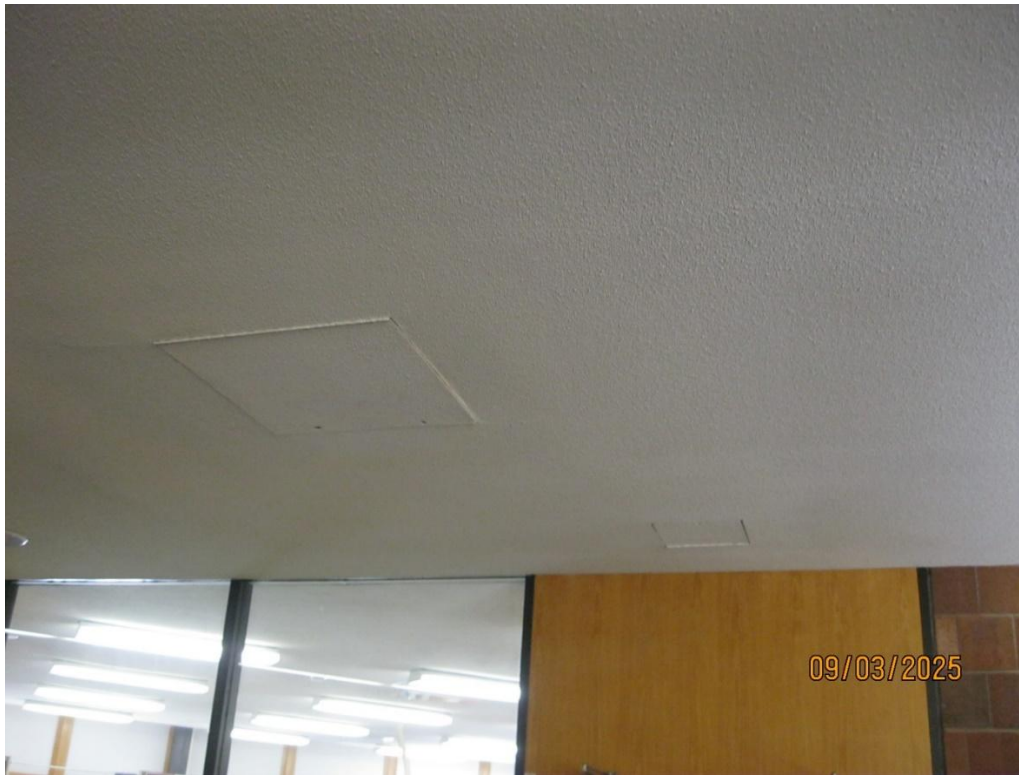
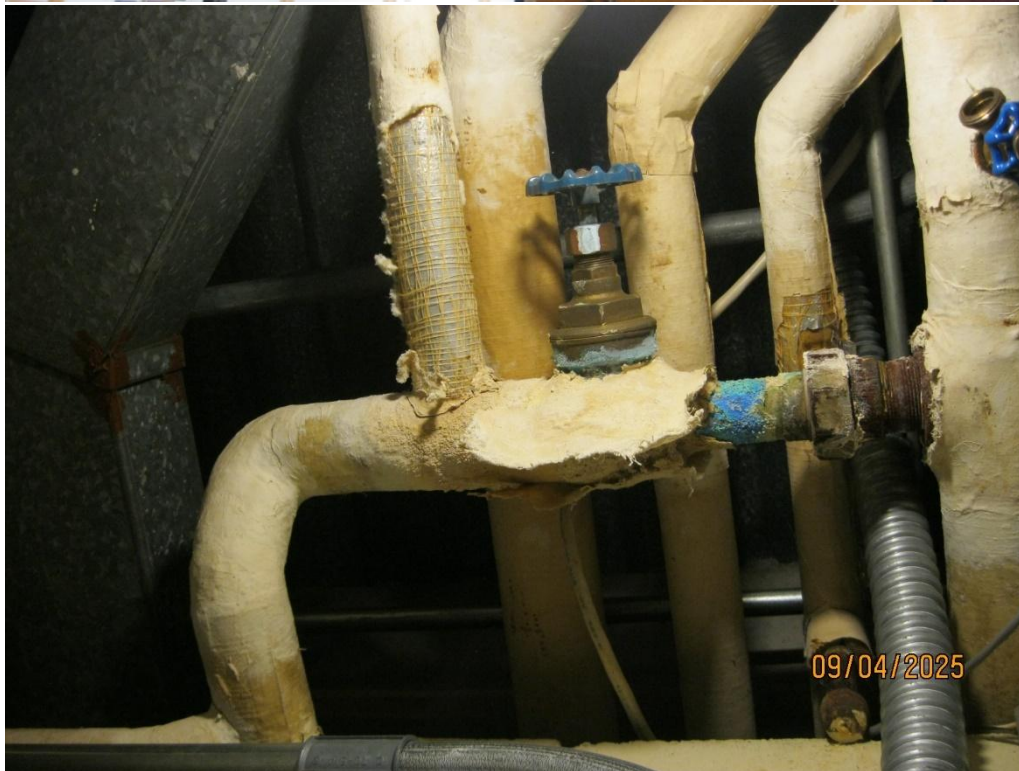
Asbestos: * Most of the ceilings in the building are coated with an asbestos material and virtually all pipe fittings are wrapped in asbestos as well.

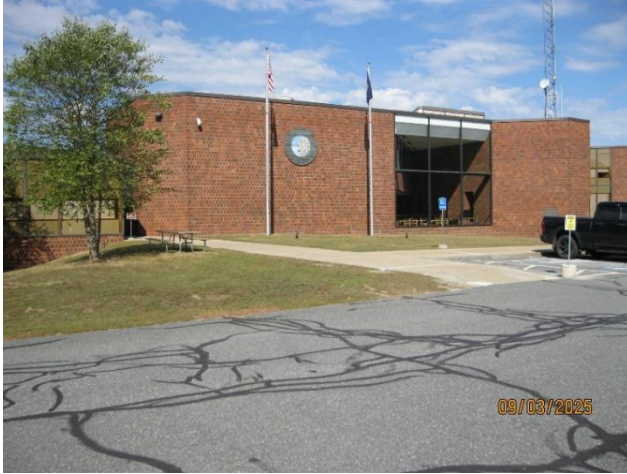
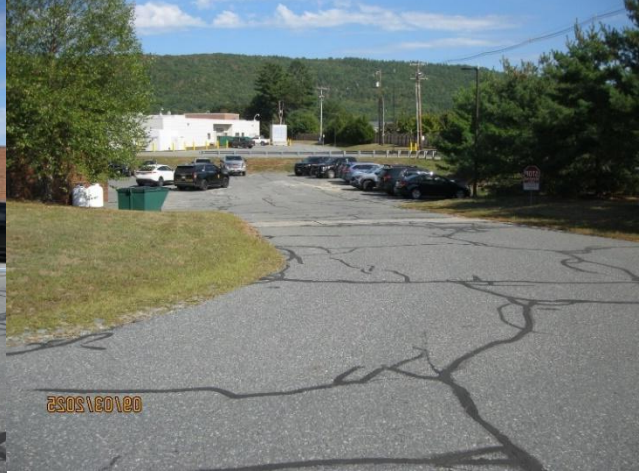
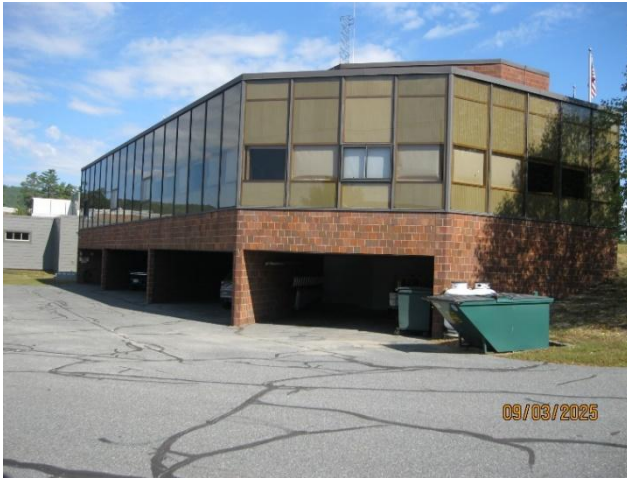
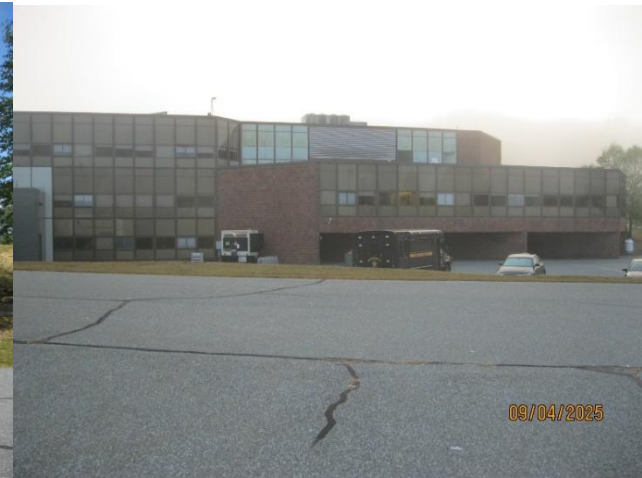
Exterior Barriers: * The facility lacks exterior barriers in key locations (lobby, jury panel room, parking below judicial chambers, generator, etc.) to prevent vehicles from impacting the building.

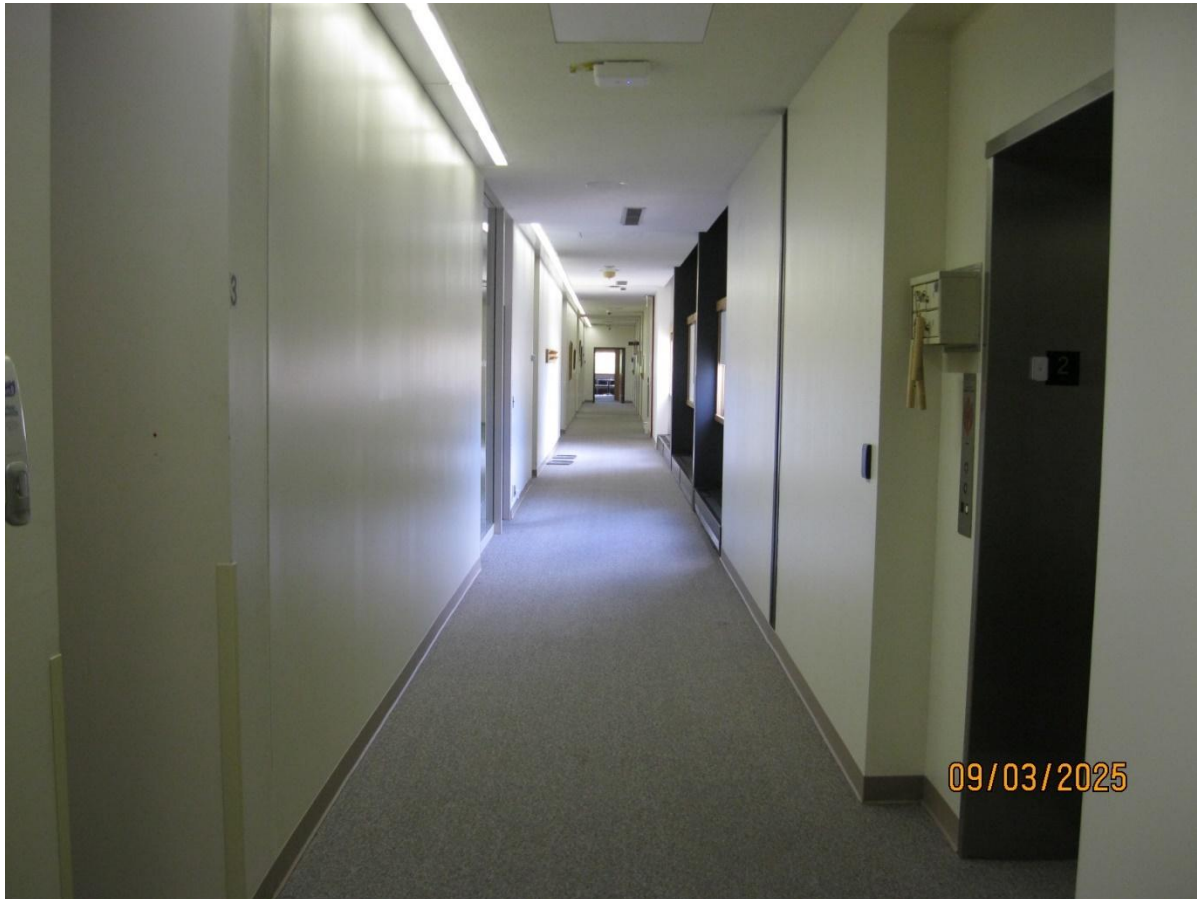
Segregation of Inmates & staff: * The building lacks segregation of inmates and staff. Inmates must be escorted from the DOC and through judicial staff areas for court appearing's because there is no other route to avoid crossing paths.

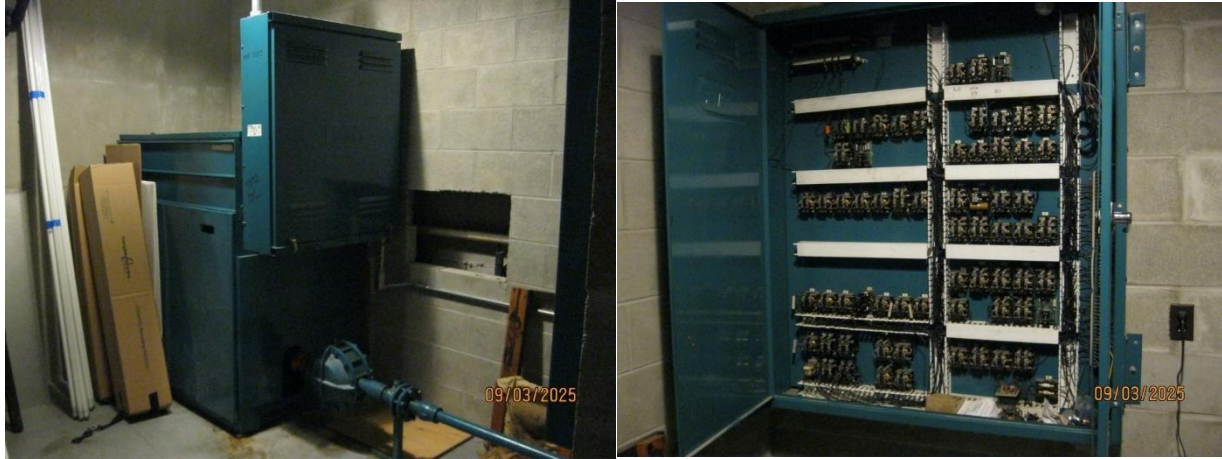
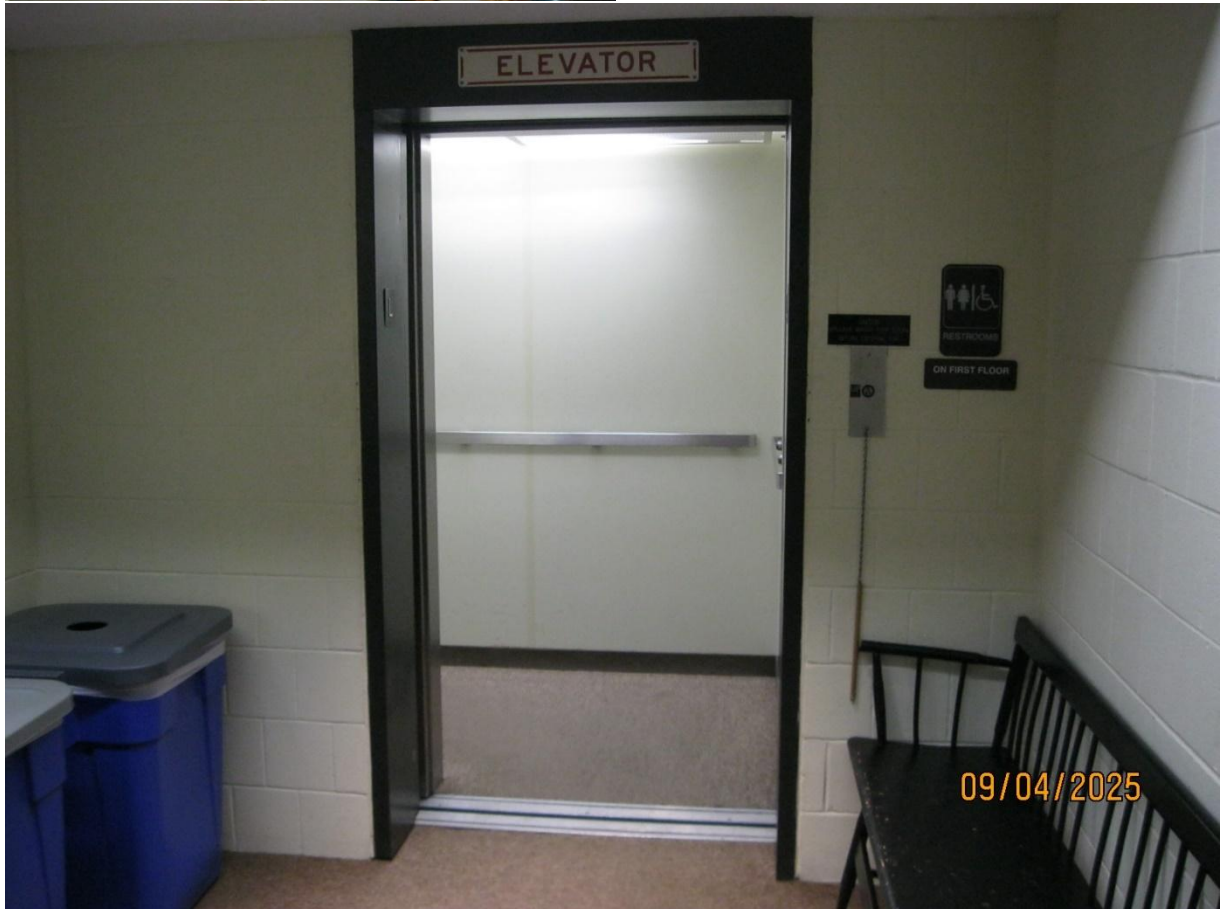
* Elevator: Certain parts are no longer available (i.e. leveling valve, relays, etc.)

Other elevator issues

- Lacks modern-day fire safety features (grandfathered by State of NH)
- Lacks true ADA compliance (buttons are too high...must use hanging wand to tap buttons)
- Electrical load exceeds generator's capacity so it is not connected

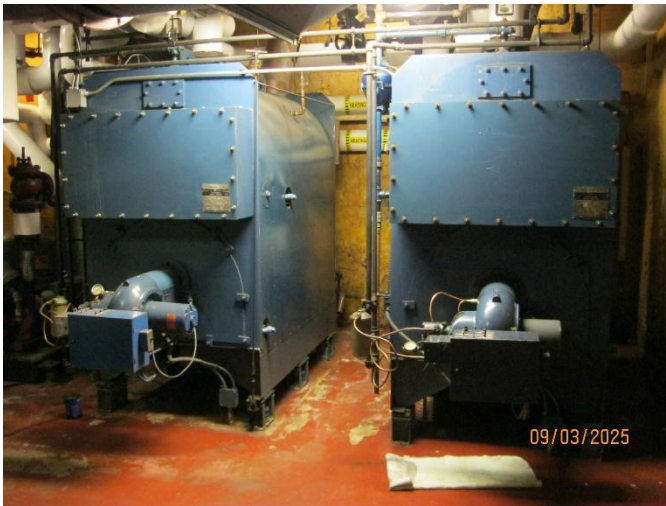
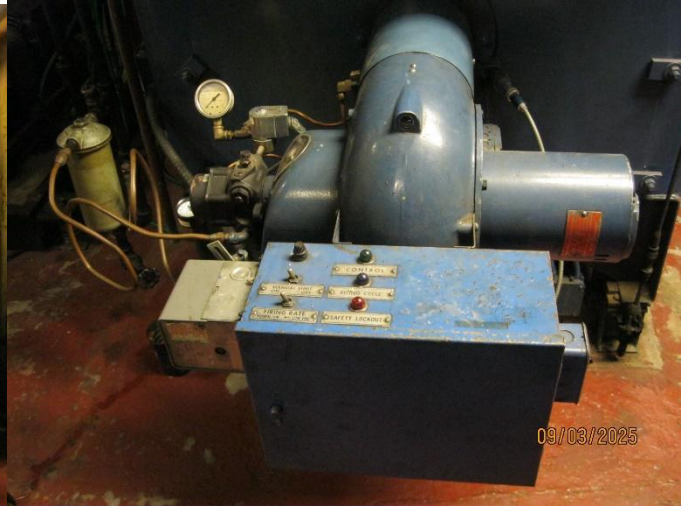
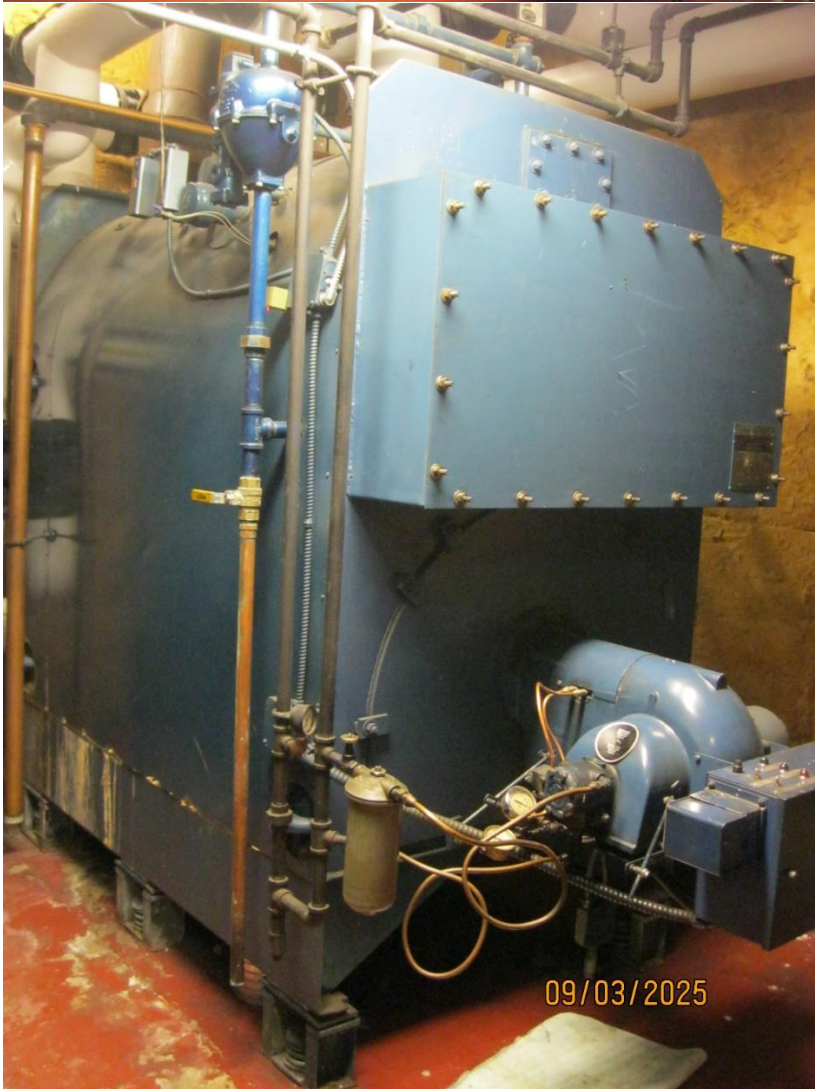
* Boilers: It is difficult to find replacement parts (i.e. low water cut outs and fuel nozzles are a few examples)

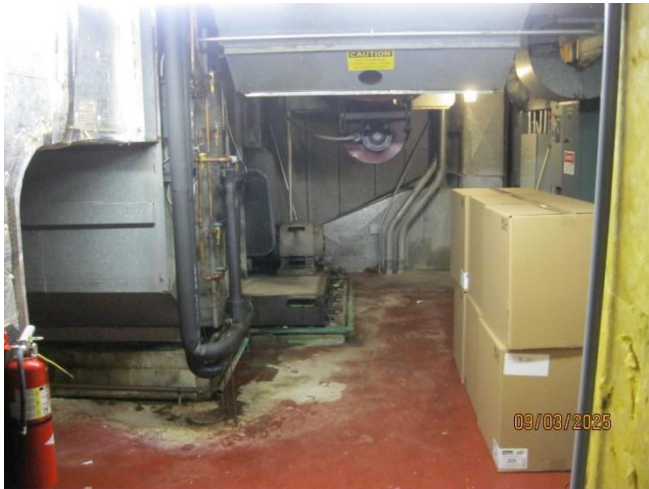
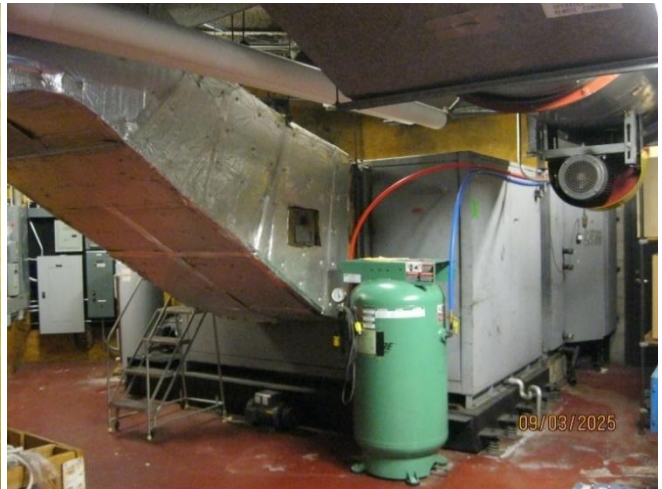
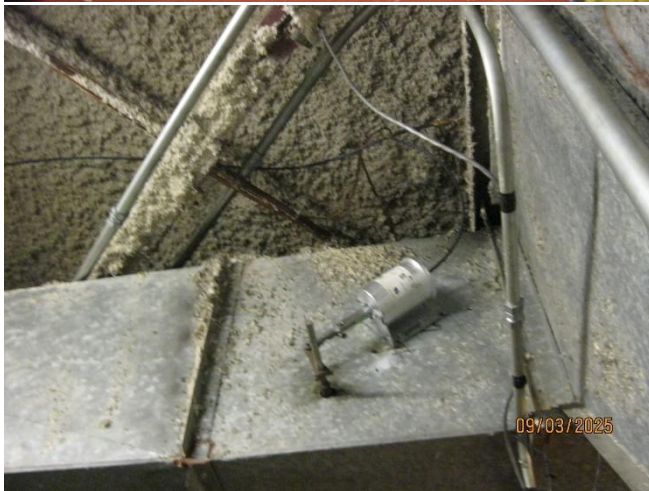
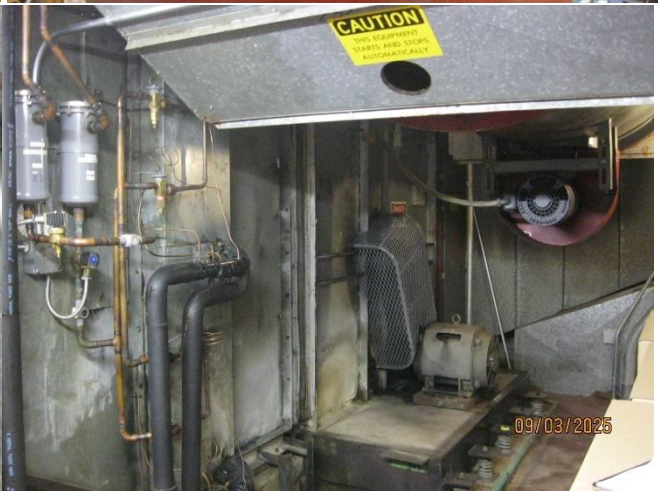
*Air handlers AC1 and AC2: Several studies show these units have had air balancing and control issues since installation, thus are extremely difficult to regulate the zoned areas they serve and keep everyone happy.

- Pneumatic controls (original) - obsolete parts and rubber parts degradation
- Ductwork insulation on interior (Concerns about doing duct cleanings and disintegration of insulating materials due to age)
- Numerous variable air volume heat boxes throughout. Many of the gate valve isolation valves for these units are seized open due to mineral deposits. Attempts to isolate them in the past has resulted in broken handles. Any further attempt to operate them now will likely result in disastrous results due to lack of larger loop isolation valves and restricted access due to a scarcity of adequately sized access doors in the asbestos ceilings.

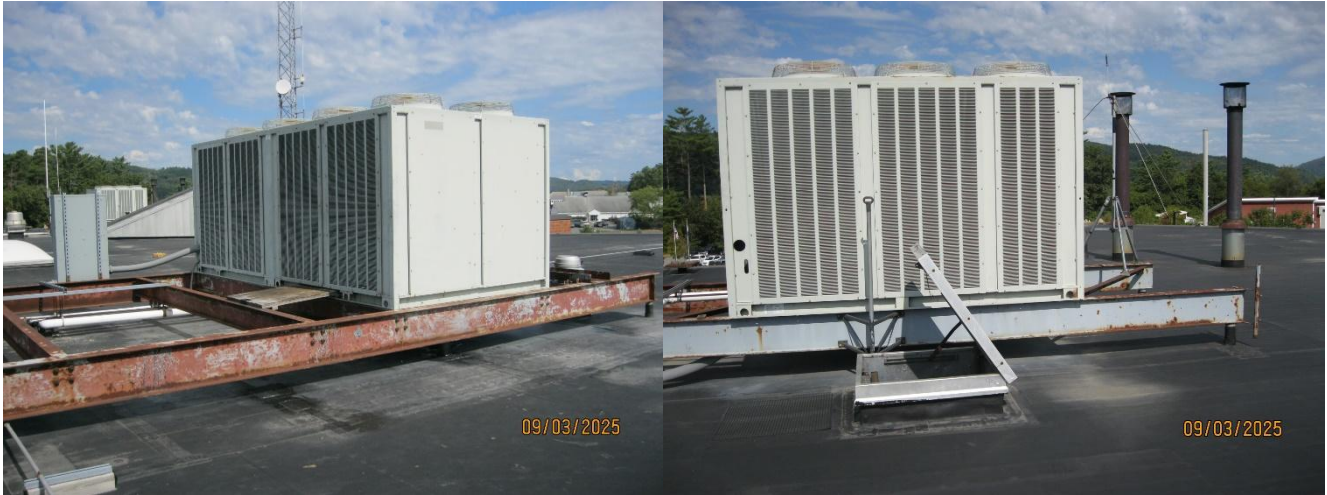
Air condition condensing units are 23-years old and at the end of their life expectancy. The R22 refrigerant they use is hard to get and extremely expensive. In the past few years a proliferation of repairs has cost the county a lot of money to keep them going.

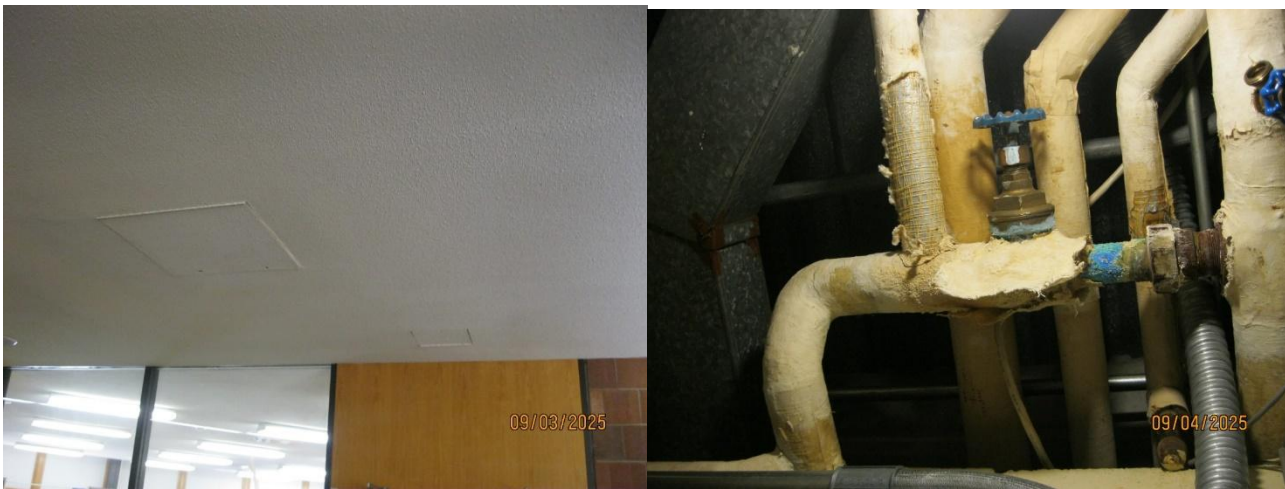
*Plumbing Much of the plumbing is encased in inaccessible concrete chases or above asbestos ceiling with little to no access. As leaks occur we have to cut access holes into the chases or completely abate asbestos ceilings to access and fix leaks. Ceiling access points are mostly small and limited, which inhibits reasonable access to much of the mechanicals, electrical and plumbing.

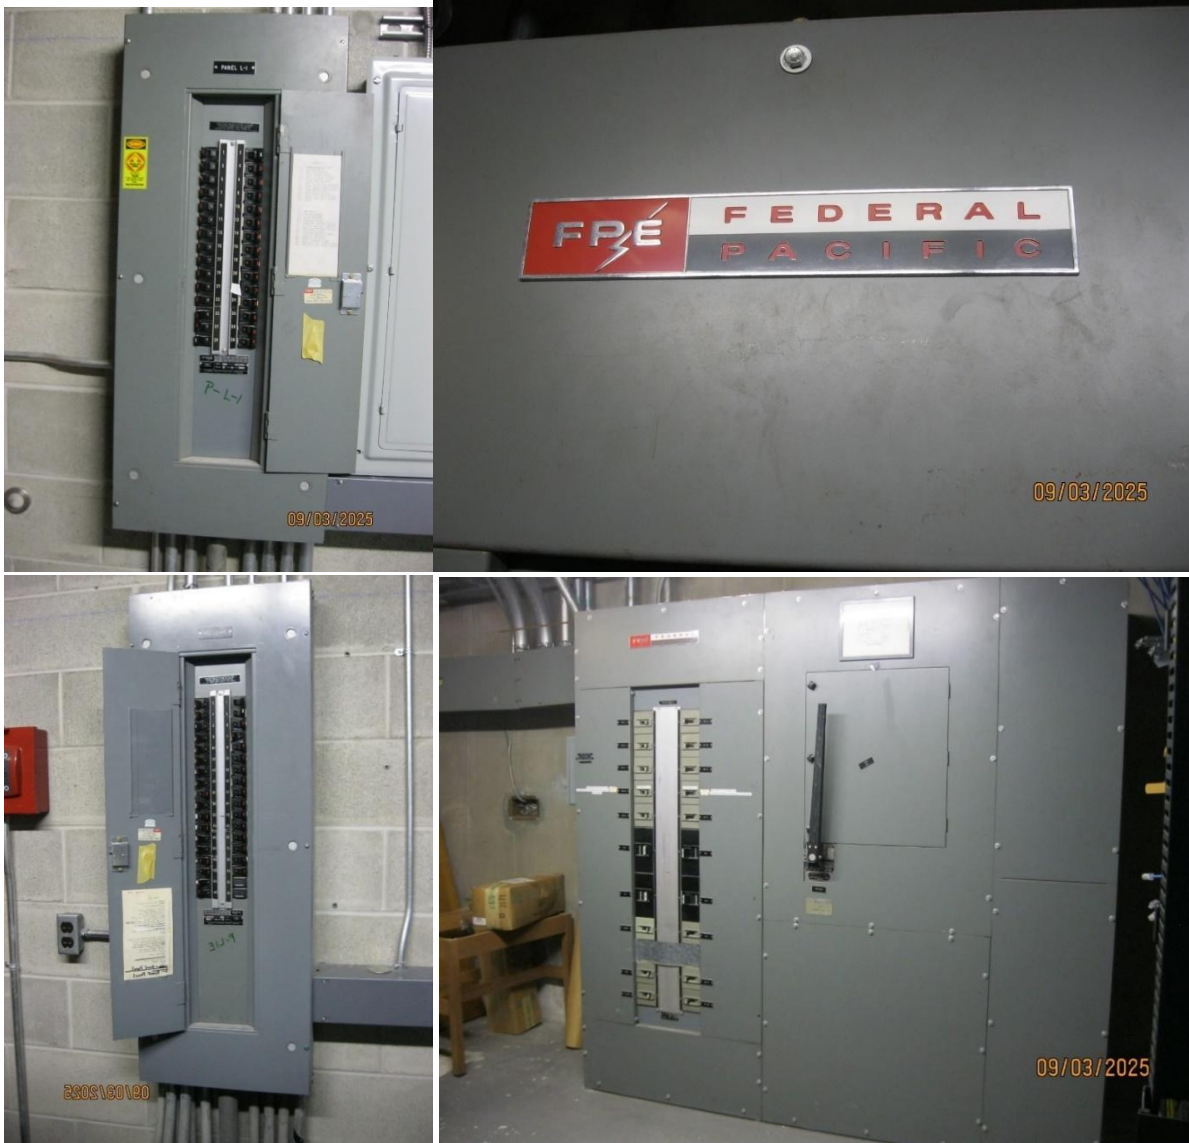
Electrical * The buildings electrical system is a Federal Pacific system. Federal Pacific was caught falsifying its UL records and subsequently went bankrupt due to a class-action lawsuit. The issue was, their circuit breakers often didn't trip when loads exceeded ratings and was cause for fires. See attached weblinks for details.

- * Mixing of 110v and 220v combination outlets (no longer meets code)
- * Using conduit as means of ground (no longer meets code)
- * Shared common neutrals (no longer meets code)
- Generator covers absolute basics (Dispatch, egress lighting, fire panel, boilers and hydronic pumps). All other occupants can't work in the building during an extended outage.
- Utility and generator circuits run in some shared raceways and shared rooms in various locations

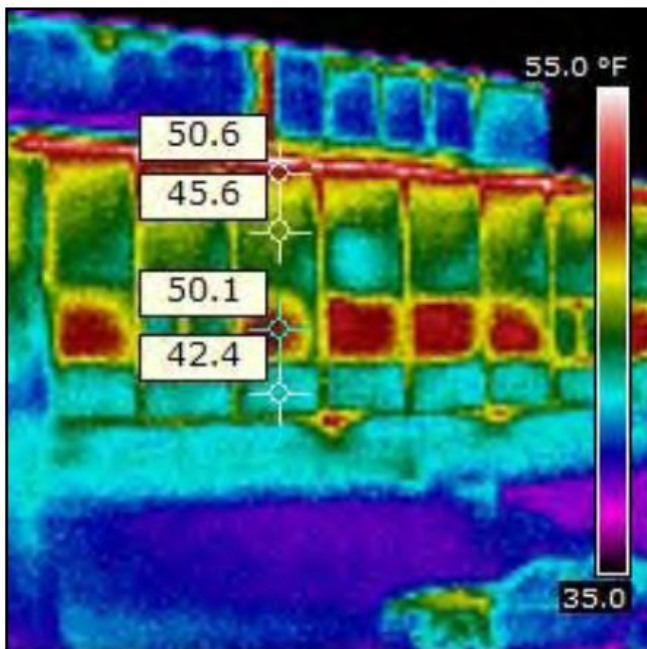
South façade of Courthouse

Insulation * - Other than the roof, which has 4-inches of foam insulation panels, the rest of the building's foundation, exterior brick walls, Kalwall translucent panels (fiberglass panels) and single-pane glass curtain walls are essentially uninsulated. Thermal gain in the summer is intensive.

Using an infrared camera on a 30° Fahrenheit day, thermal scans from a 2009 energy audit revealed massive heat losses and assumes the same for cooling losses in the summertime. Below are a few images

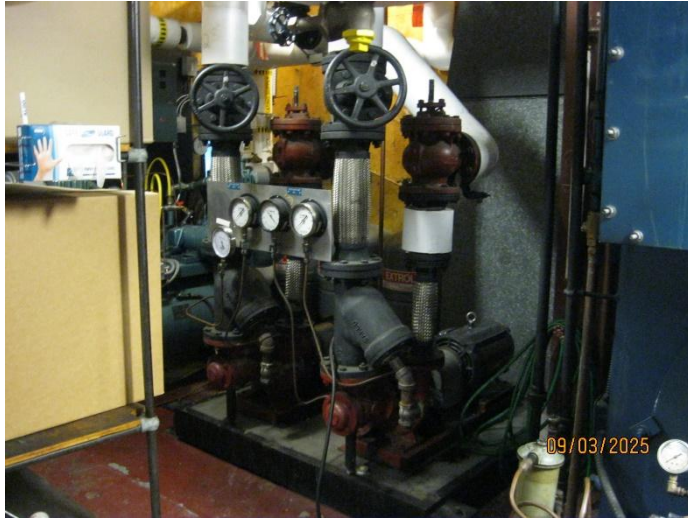
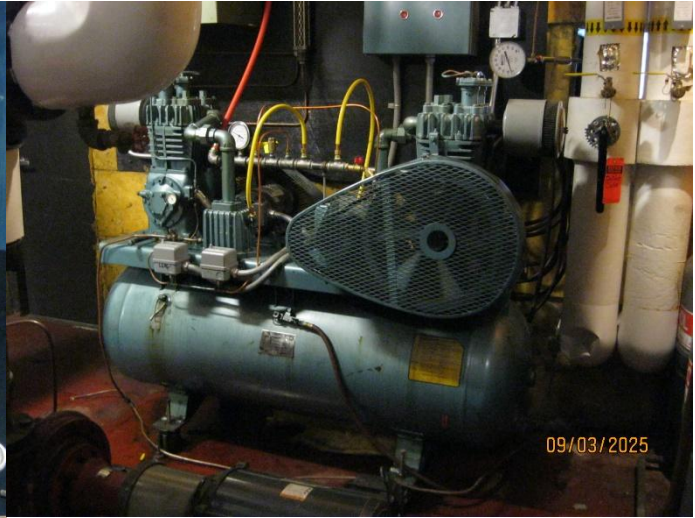
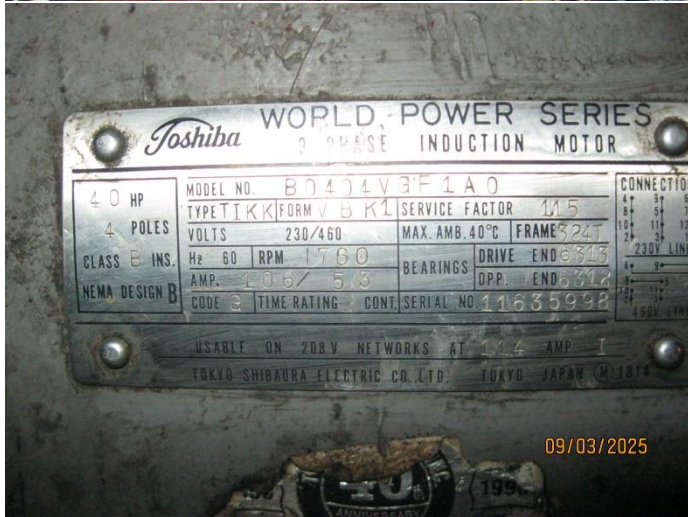
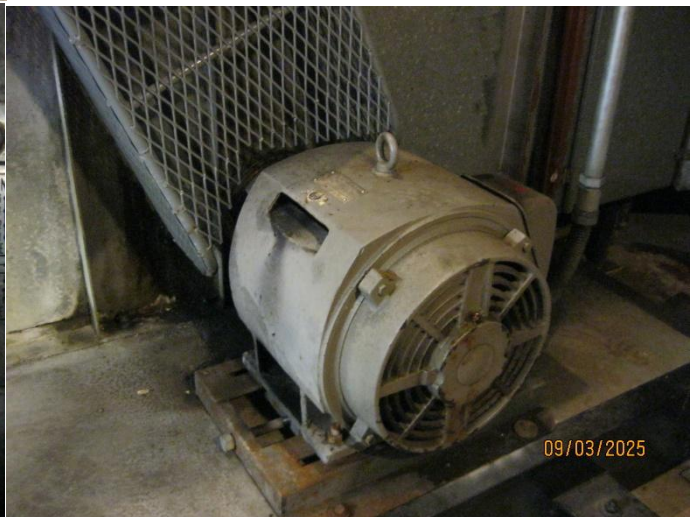
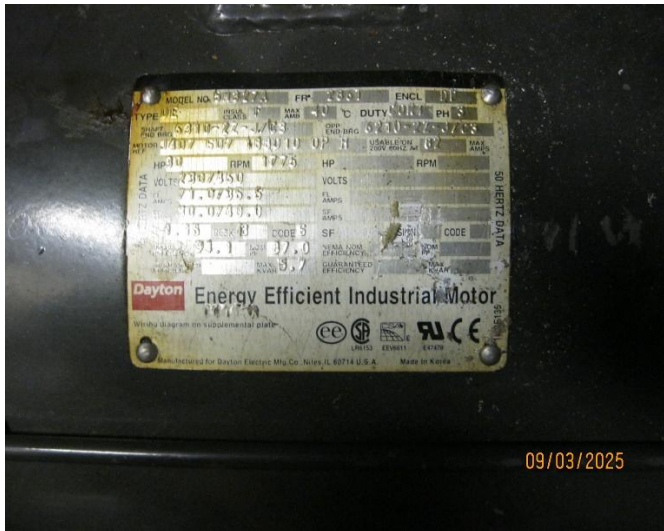
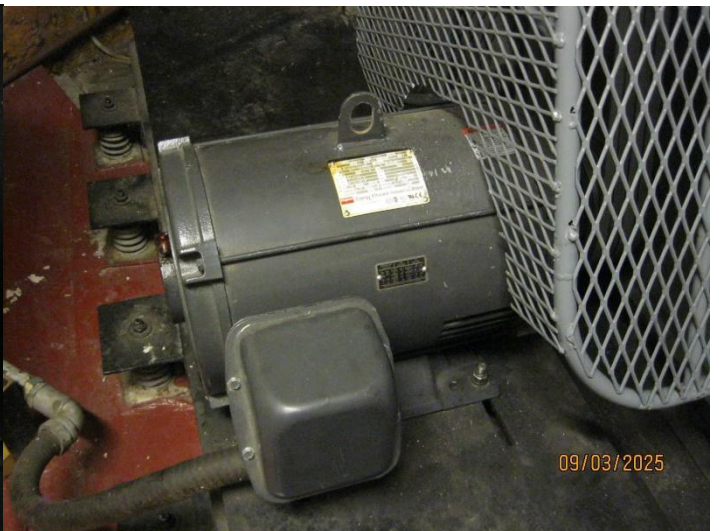
Mechanicals - Virtually all of the mechanical equipment (boilers, pumps, air handlers, etc.) are 55-year old equipment and well beyond their life expectancy. Although still operational, they are hugely inefficient when compared to modern day replacements.

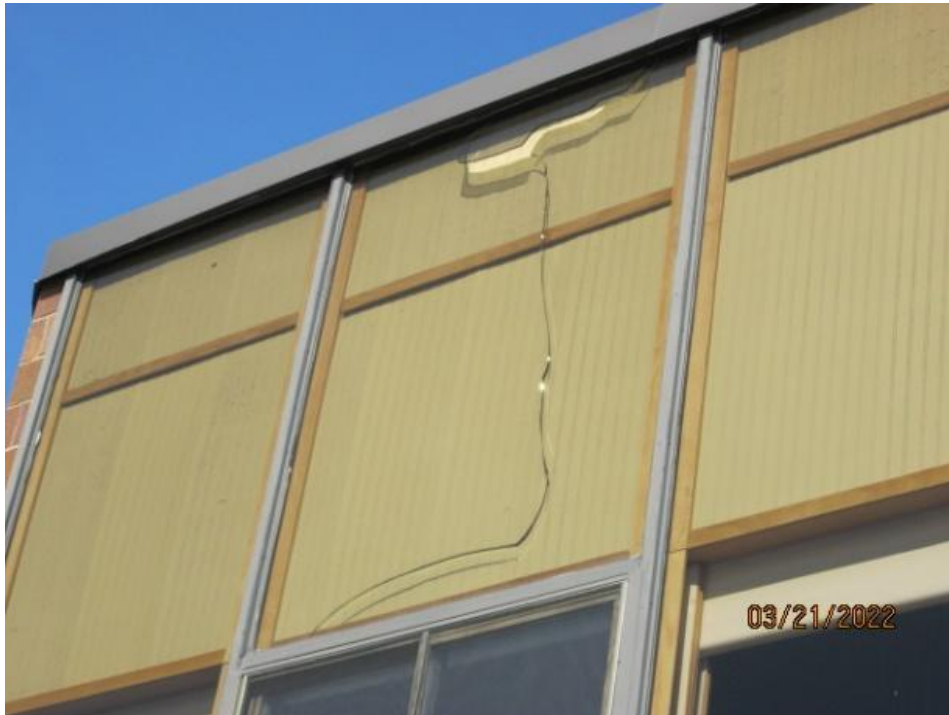
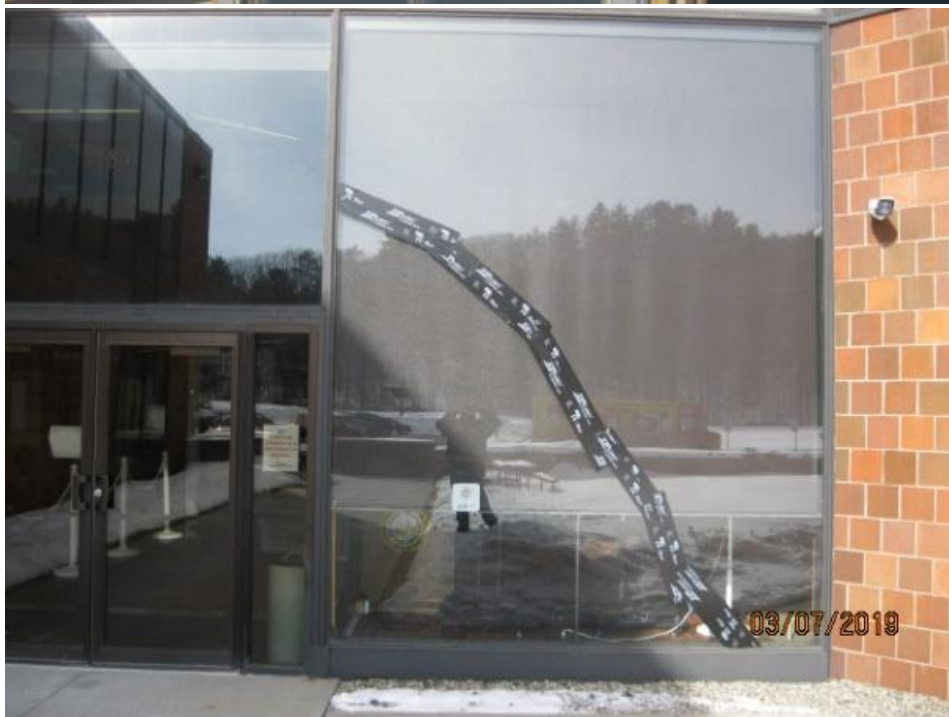
Glass curtain walls – The steel frame interiors are rusting and the pressure from the expanding rust leads to cracking of these massive windows. The windows then break into large jagged shards, unlike today’s safety glass designed to break into small pieces to mitigate injury. Replacement glass must be safety glass and thus it can be problematic procuring the large sizes we need due to tempering oven size limitations. Lastly, replacement glass is quite expensive. For example, in April 2019 it cost \$21,570 to replace one pane of glass at the main entrance.

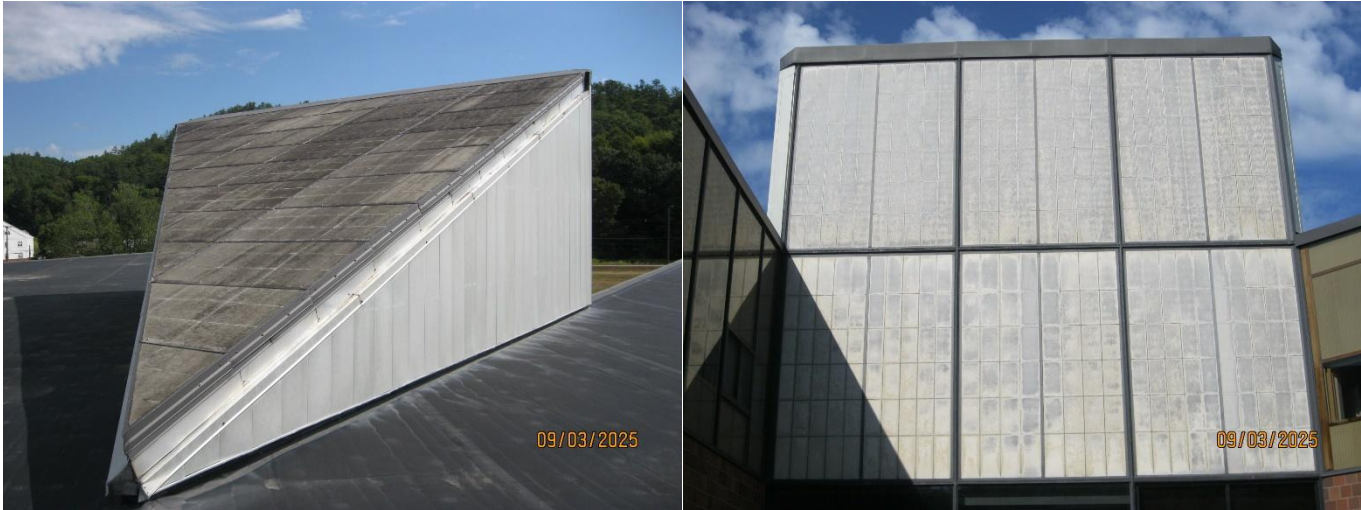
Kalwall Translucent panels (fiberglass) – The front entrance curtain wall and atrium roofing over the lobby are made up of Kalwall translucent panels. UV rays have degraded the panels to where they are thin and brittle. They are well beyond their life expectancy and sometimes leak during a driving rain.

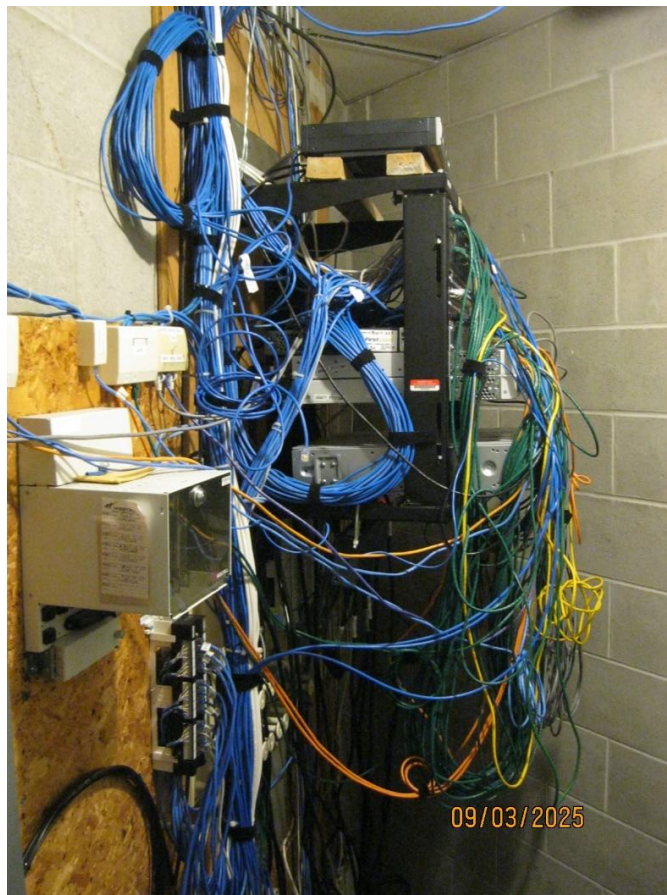
IT closets – The building was never constructed to support IT equipment. Over the years the county and state IT departments set up their equipment wherever they could. Most are jammed into cramped electrical rooms that are not air conditioned.
