Grafton County Courthouse – Facility Concerns

(* Denotes 54-year-old original equipment dating back to 1971 when the building was initially opened

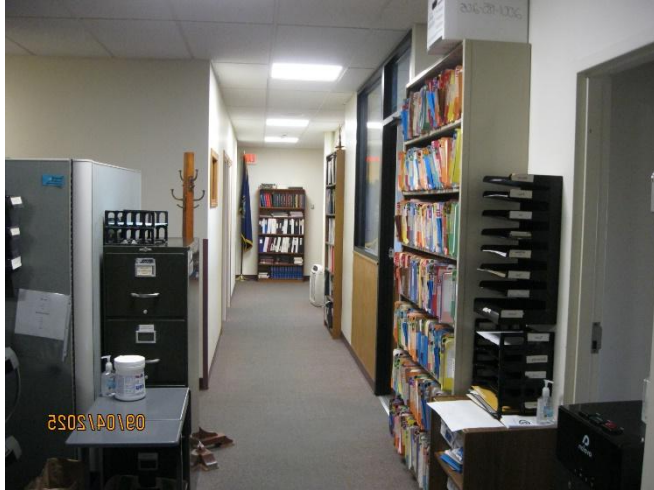
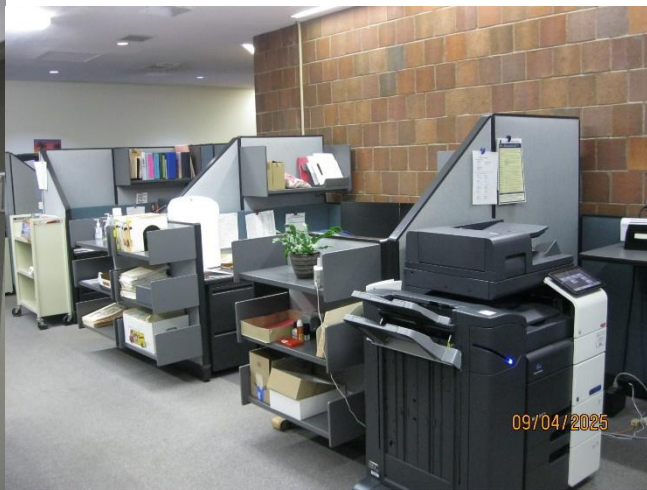
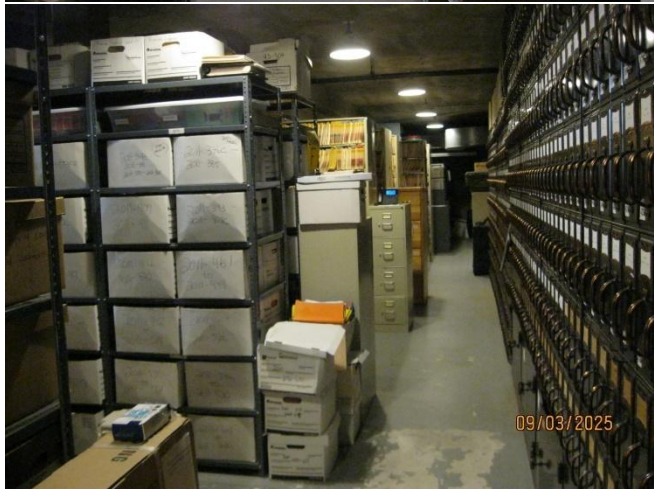
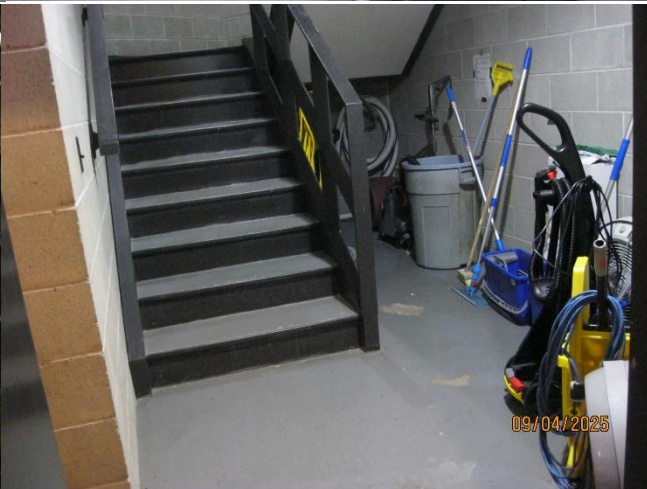
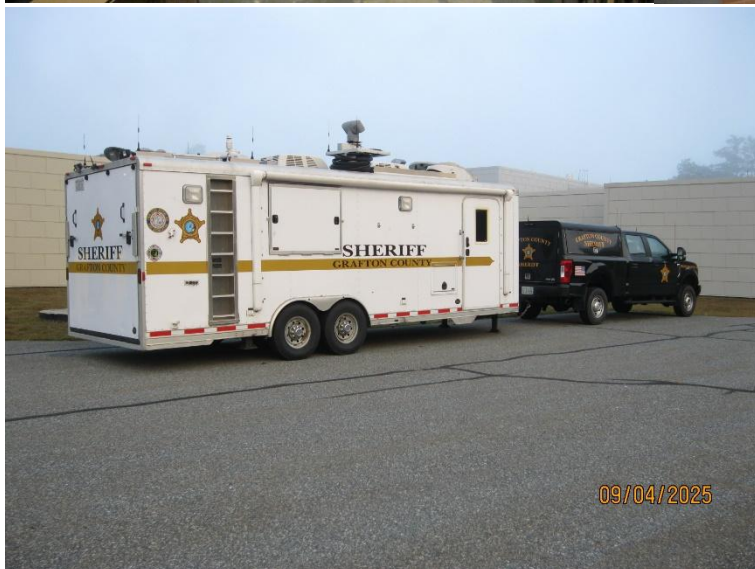
Office Space & Storage – Virtually all departments and agencies have grown exponentially since the building opened in 1970. Today, many staff areas are cramped and lack of adequate storage space has caused storage to encroach into staff areas and stairwells. Shared storage is jam-packed and overflow often jams office space. Dispatch's Mobile Command Center trailer and tow vehicle sit out in the weather and should be garage to promote longevity.

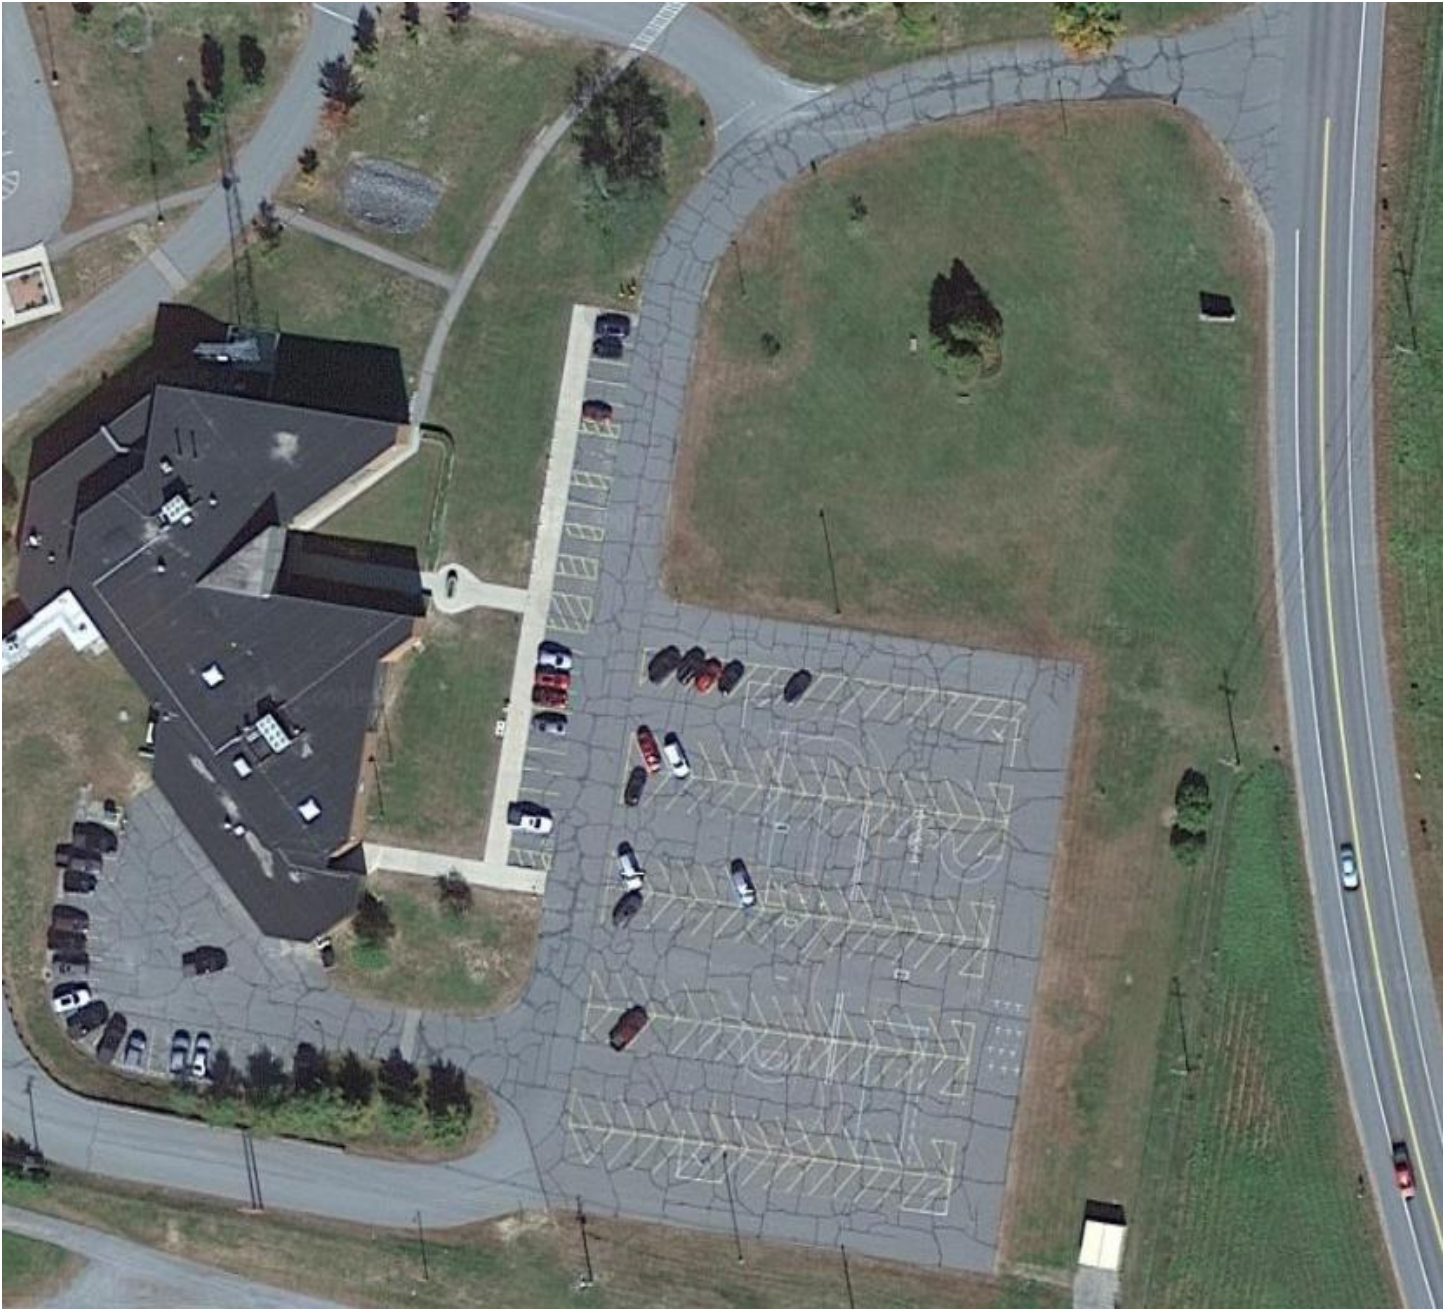
Parking Lot – The pavement is degraded to the point where the base material has failed, which requires complete removal and replacement.
